# Memorandum from RCC

**Re:** Pre-drywall inspection: Lot 868, 833 Gillinder Place, Cary NC 27519

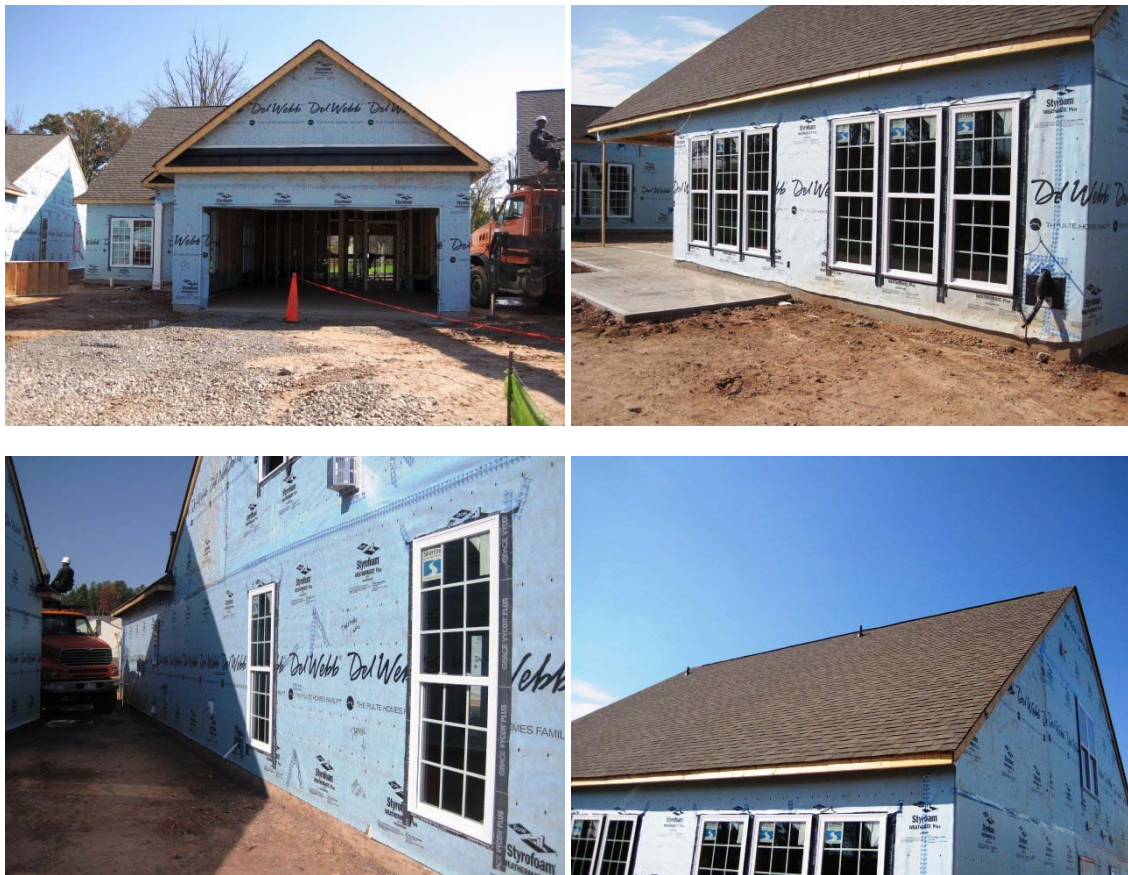
The site has been rough graded in a satisfactory manner so as to not hinder construction after heavy rains. With a few exceptions, the home is ready for the insulation and drywall to be installed.

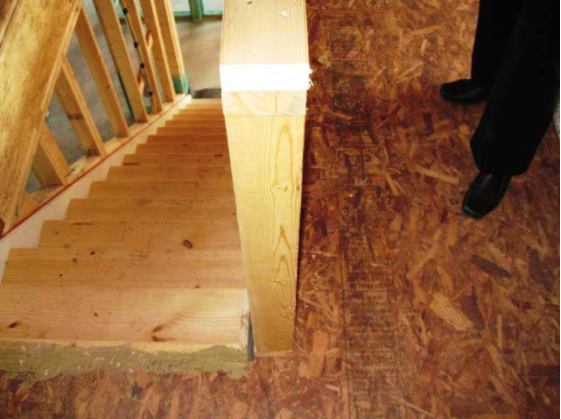
1. The main concern of the buyers is the 2 by 4 half wall/railing in the loft. No part of the railing is embedded down into the floor system. Based on prior experience in another home, they are concerned that when pressure is applied to the railing at the top of the stairs the sheetrock mud may crack. This could cause undue settlement because the wall/railing is not properly anchored.

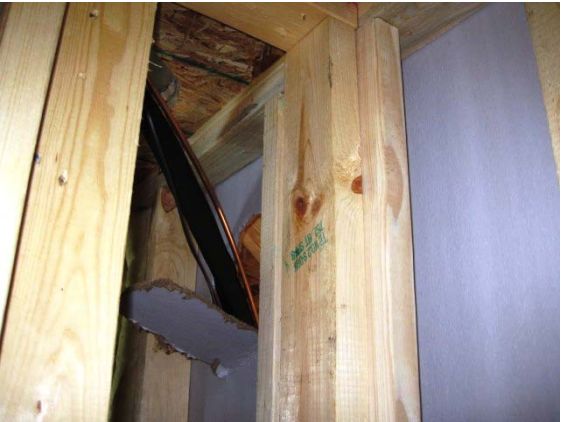
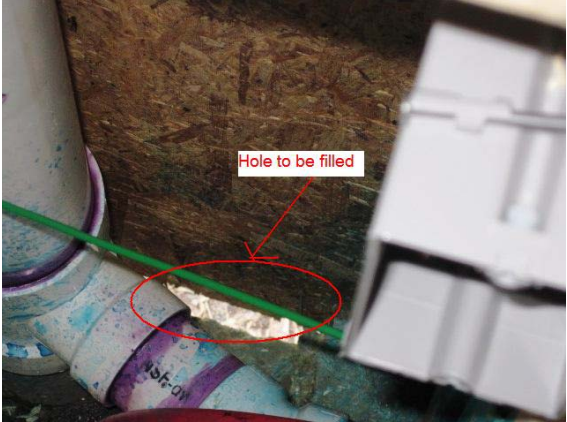
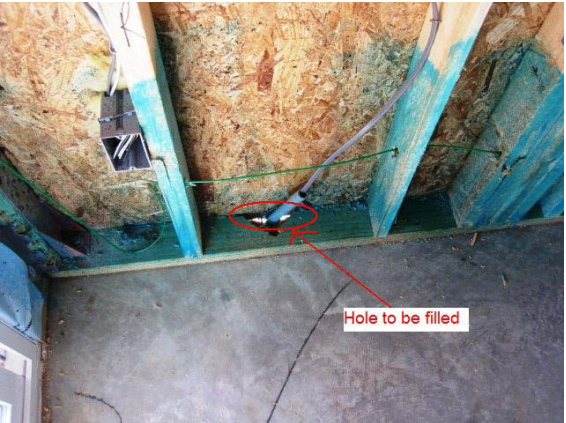
2. There is a large hole at the rear left wall where the Freon lines pass through. There are several holes between the bottom sill plate and the concrete slab that create voids from the exterior wall cavities between studs; the right side near the rear is a good example. The holes and voids should be filled with expandable foam.

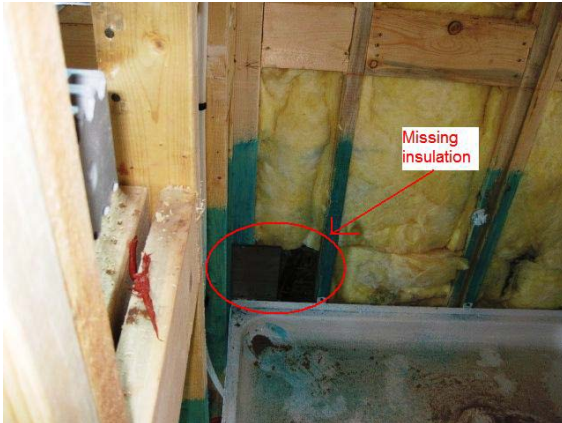
3. There is a piece of missing insulation near the shower pan at an exterior wall.

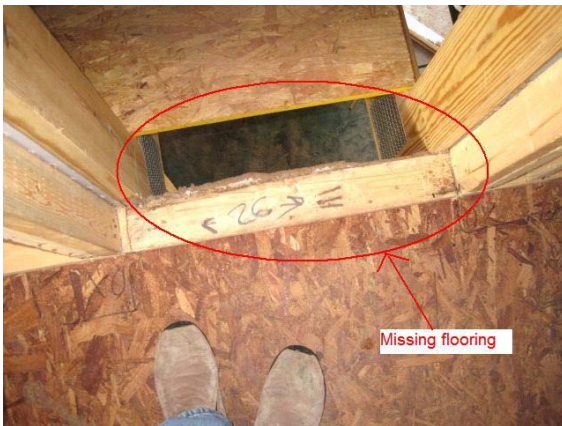
4. There is a piece of flooring missing at an attic eave access.

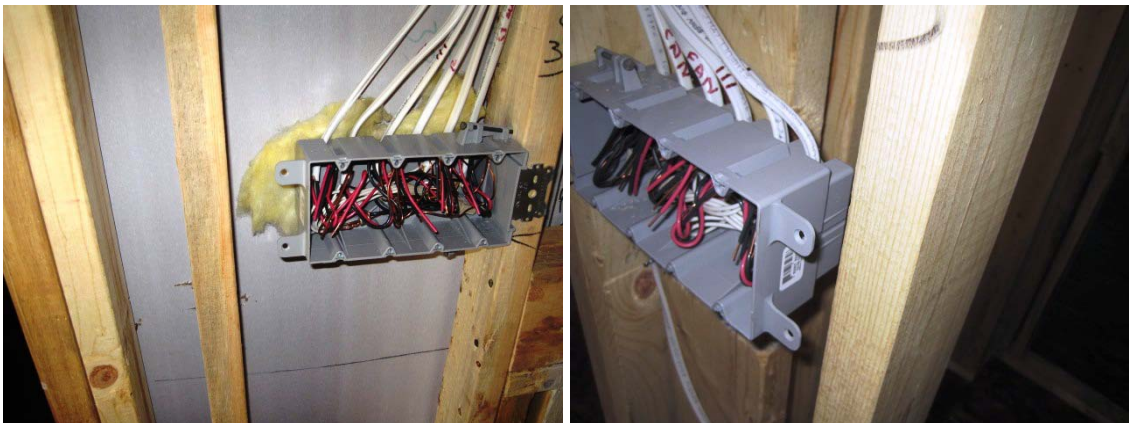
5. A few large switch plate boxes need to be supported on both sides by adding wood blocks to existing studs.
