BUILDING INSPECTION REPORT

Age: 1920, remodeled 1999

Date: March 12, 2008

Structural and Mechanical Inspection

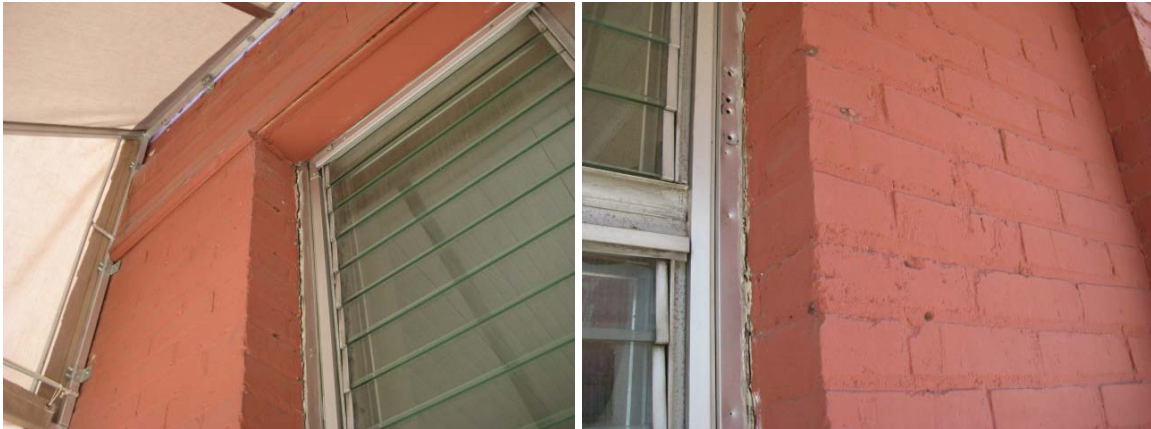
3. The exterior of the building is composed of the masonry material with which the building is constructed.
4. The building has gutters and downspouts at the rear and a cloth awning at the front.
5. [The frame of the front window needs to be sealed to the masonry surround.]

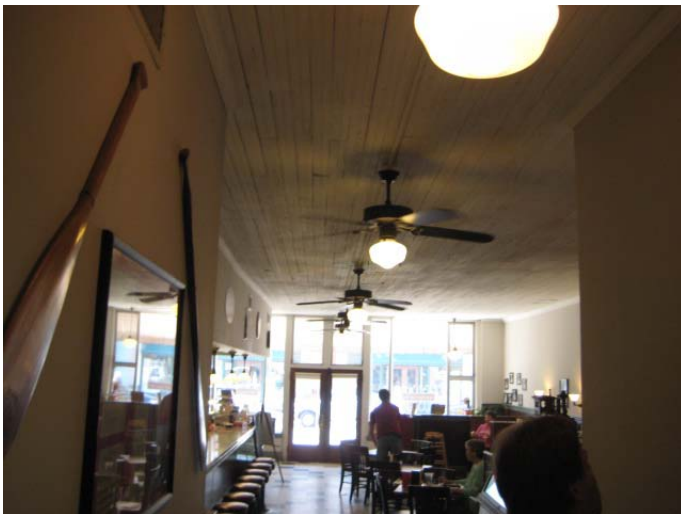
6. The store front windows are metal frame jalousie and single pane picture units.
7. The wood ceiling of the main restaurant room has numerous patched access openings that are nailed shut and painted over.

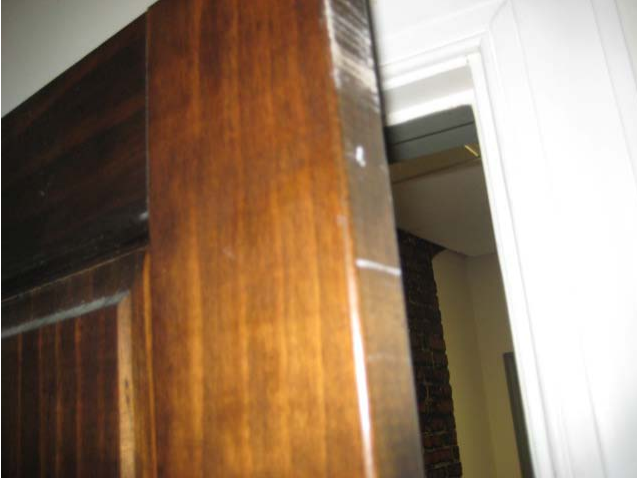
8. [The wood door between the rest rooms and kitchen rubs its frame and needs to be adjusted to operate properly.]

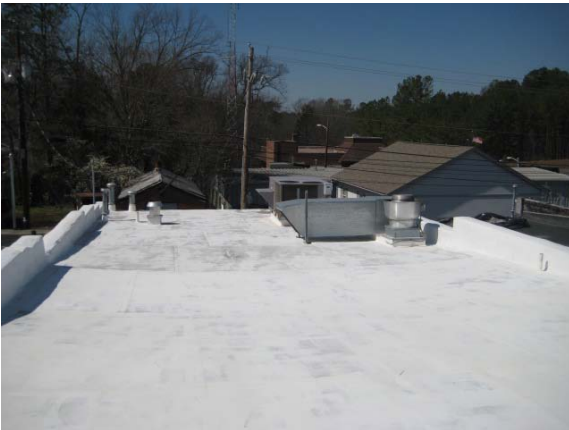
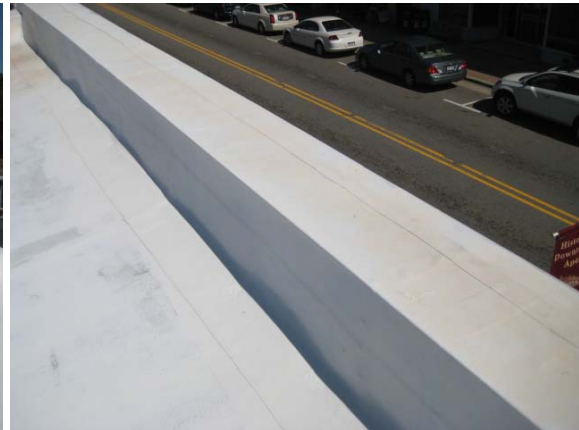
9. The fairly flat roof is a painted rubber polymer system and is in good condition. The flashing is done properly and the other roof penetrations are properly sealed.

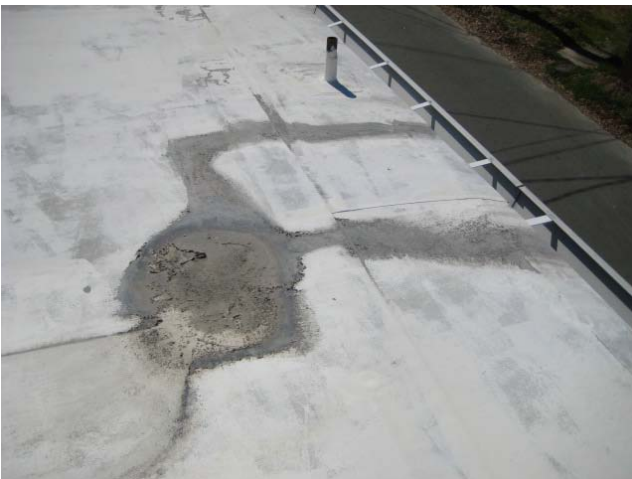
10. [A stain from minor ponding, from the condensation drain, is beside the AC unit on the roof. The condensation drain pipe from the unit should be extended to the gutter rather than run onto the roof.]

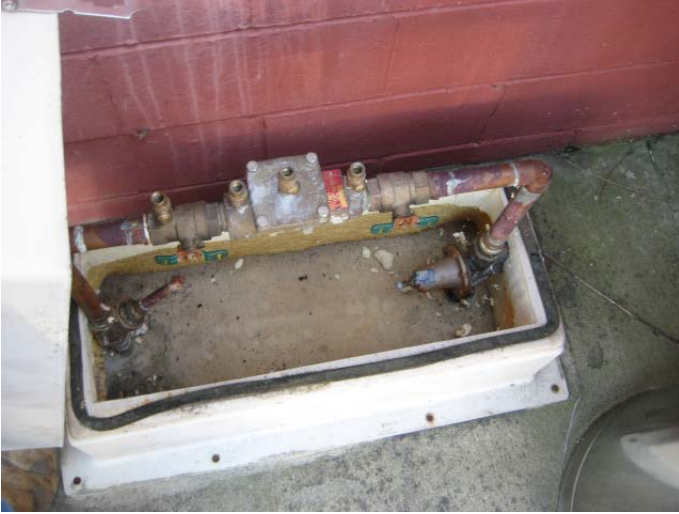
13. The main shut off valve for the water is located at the rear of the building.

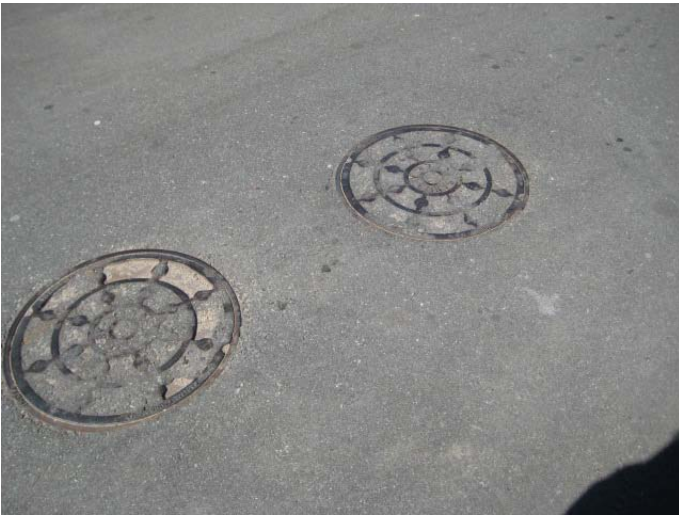
14. Two grease traps are located in the alley behind the building.

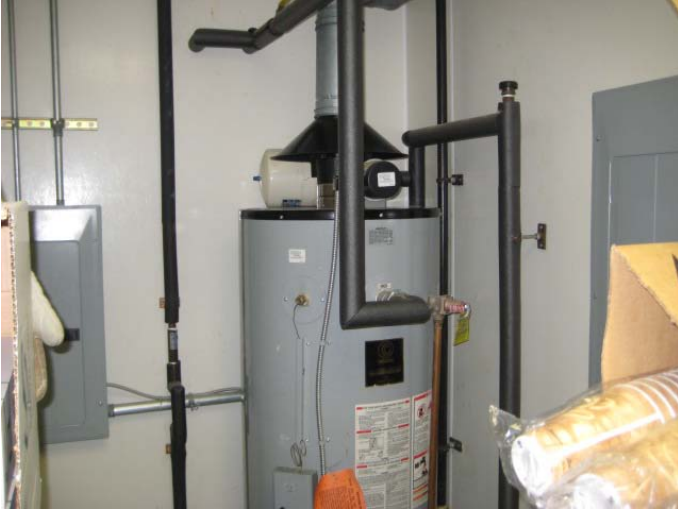
15. The water heater is an 8 year old gas unit located in the kitchen.

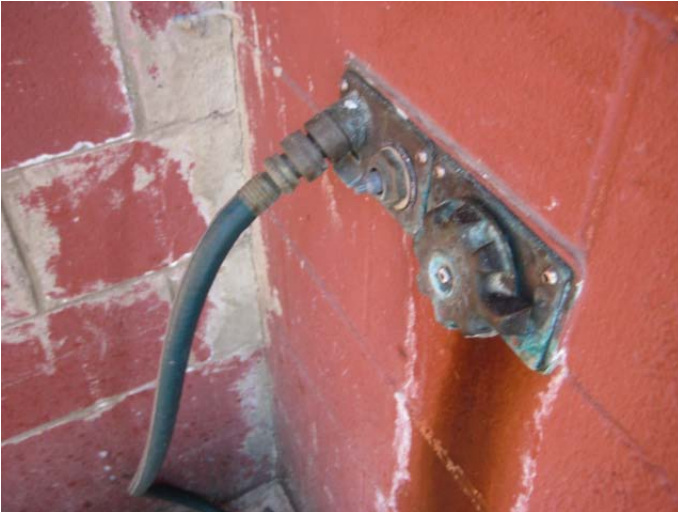
16. [The rear exterior hose bibb is leaking from its mixing valve and the on/off valve is missing a handle.]

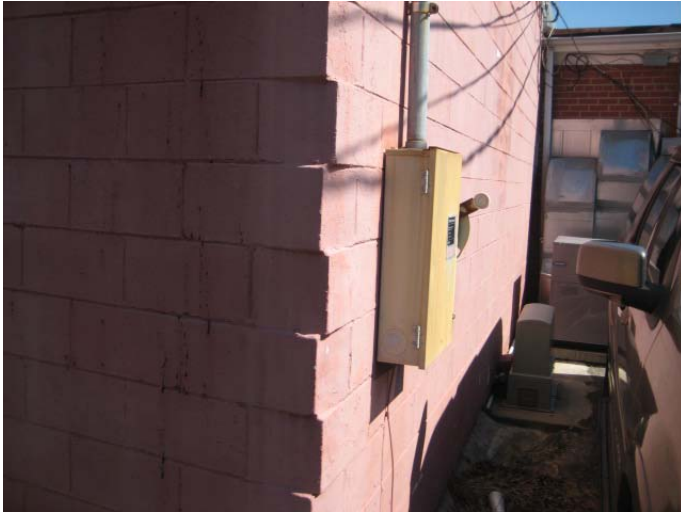
17. The building has overhead service (220/110 volt) to the meter.
18. The main circuit breaker panel is located at the exterior of the building. It is a 200-amp 3-phase service and is fed with 4/0 AWG copper entrance cable. This size service should be adequate for the building. The cover could not be opened without shutting off the power to the building.

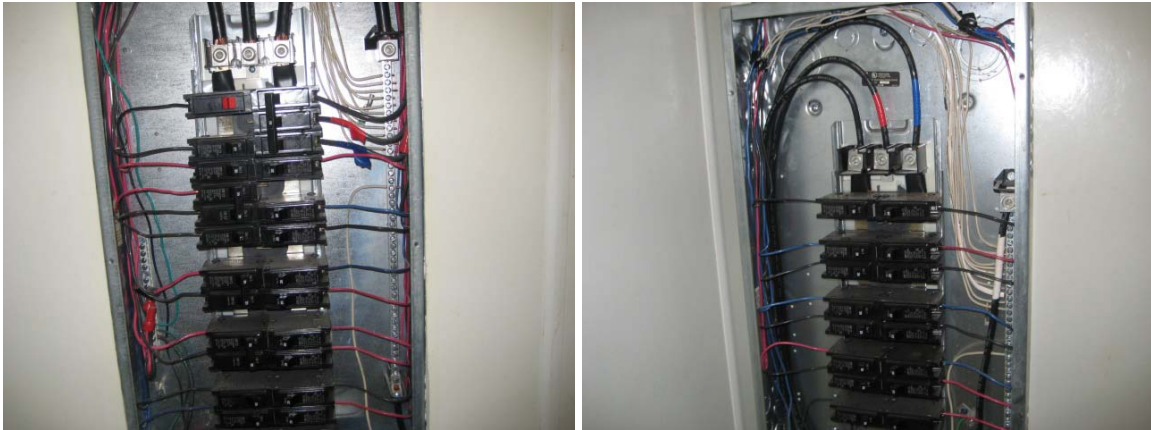
19. The two sub-panels for the branch circuits are located inside the building. The circuits for the lights and plugs are wired with copper wiring.

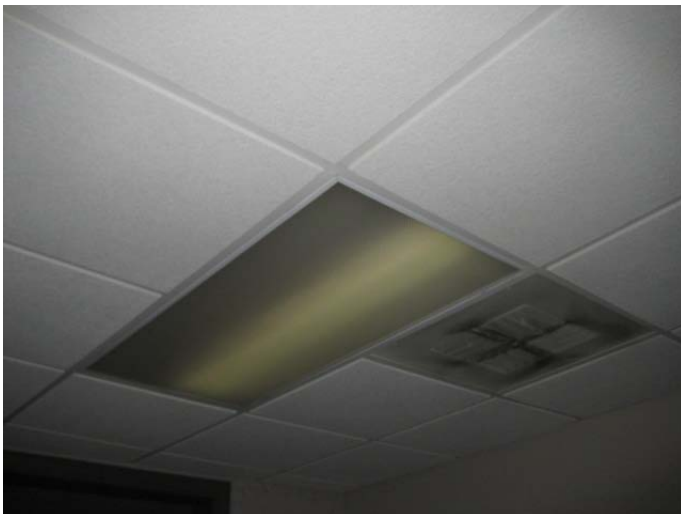
20. [A fluorescent light in the office ceiling does not turn on.]

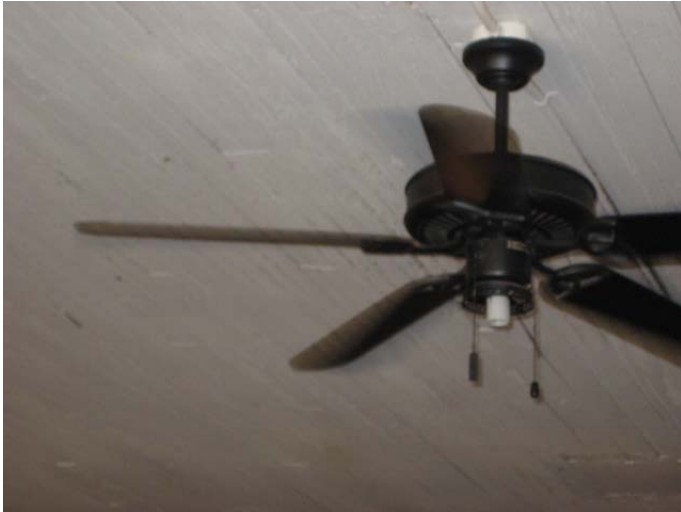
21. [A ceiling fan and light fixture is missing its light bulb and globe.]

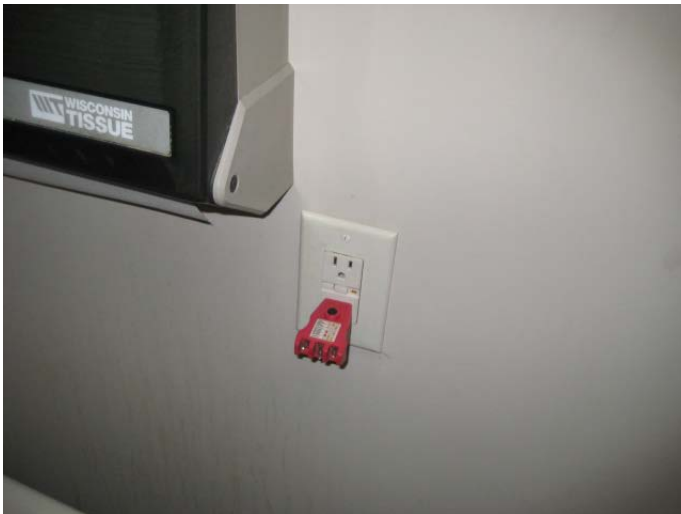
24. **[The GFI receptacle in the men's bathroom is loose and needs to be secured.]**

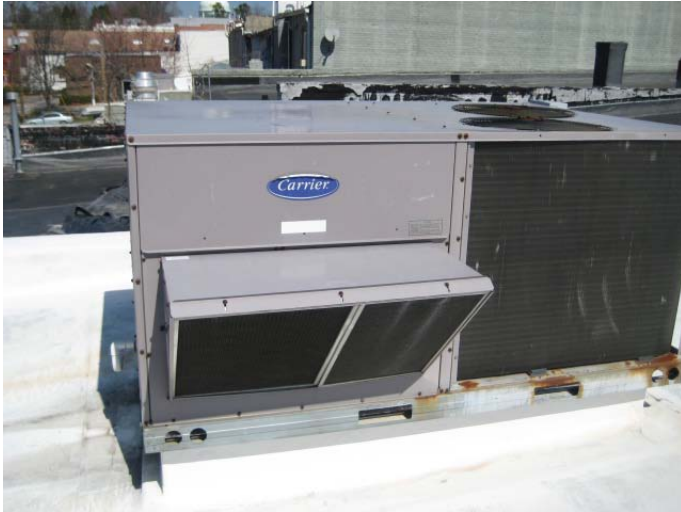
26. The building is heated by an 8 year old, gas, warm forced air furnace, located on the roof in a unit called a gas pack.

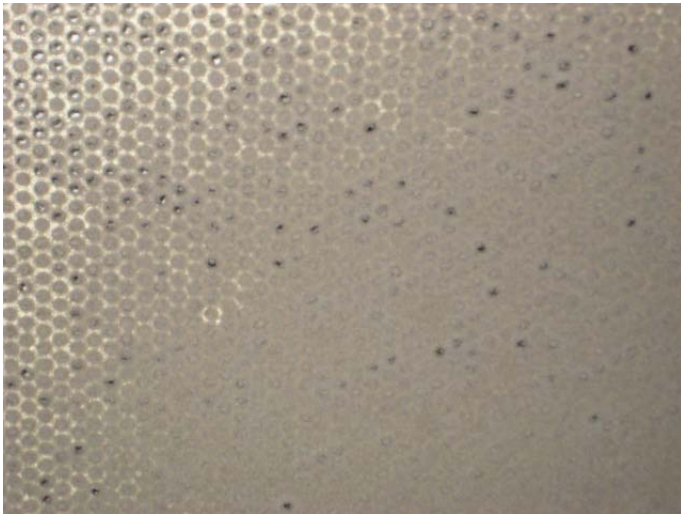
27. [The furnace would not respond to its controls and should be evaluated by an HVAC technician and repaired.]
28. [The unit has no filters at its air-intake on the roof and there are no filters at the return air registers inside the building. An HVAC technician should install the necessary filters and service and clean the unit as needed. The return air grills inside are also dirty and need to be cleaned.]

29. The filters should be changed once a month before they become dirty.
