WATER PENETRATION INSPECTION REPORT

Date: January 8, 2010

Water penetration inspection

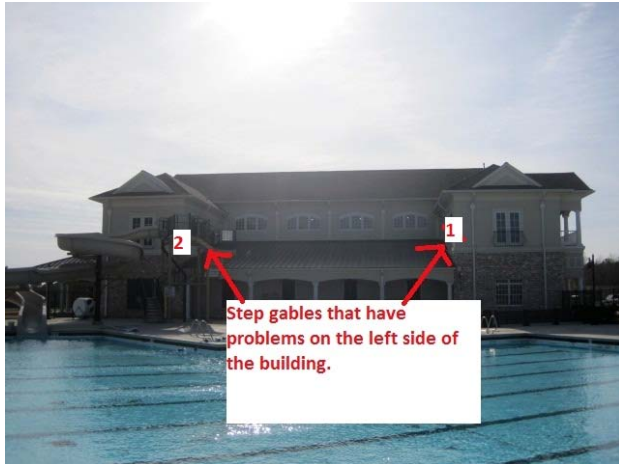
Step gables 1 & 2 at the left side of the building.

All four of the step gables have numerous penetrations in the stucco where the shutter hardware is installed. There are also gaps in the flashing and caulking at all the step gables. I have marked all four of the step gables with painters tape pointing to all the obvious areas where water could penetrate. I have also marked the rear second floor balcony doors where there are obvious water penetrations.

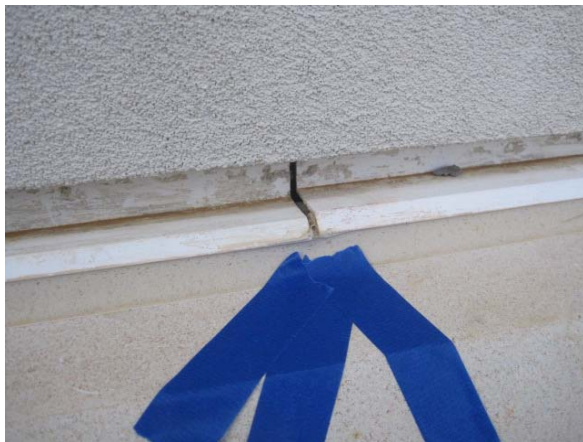
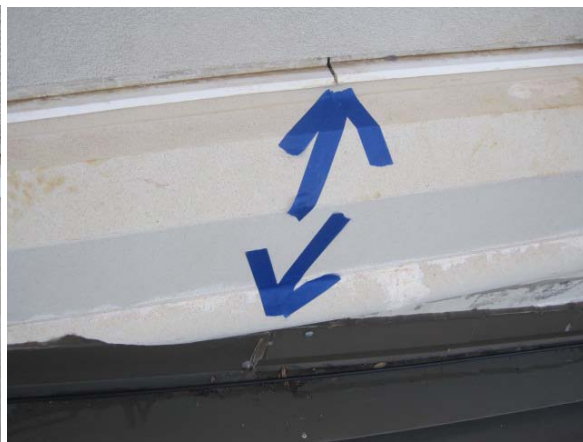
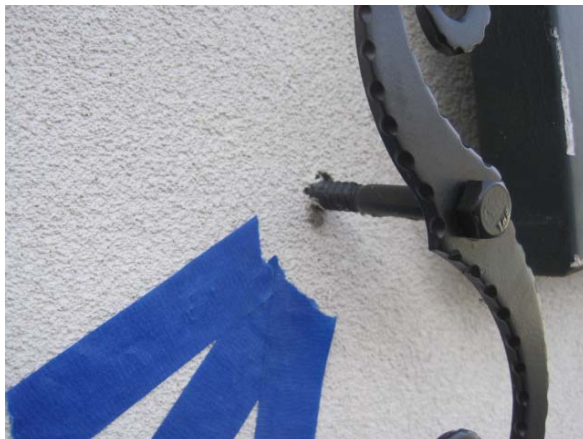
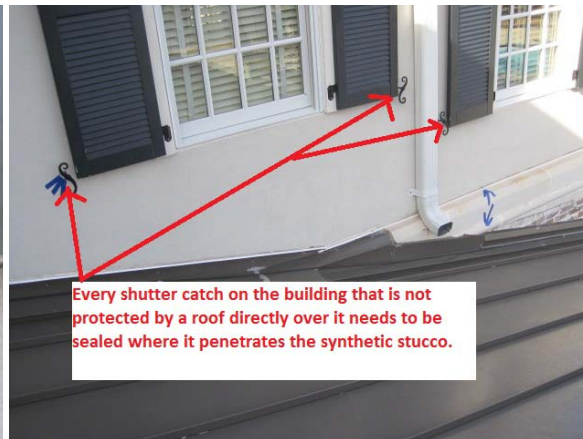
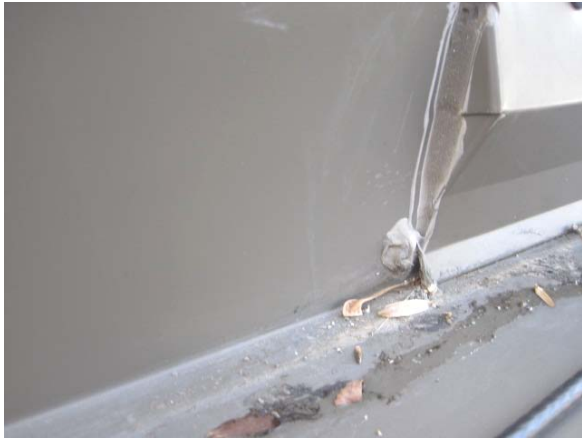
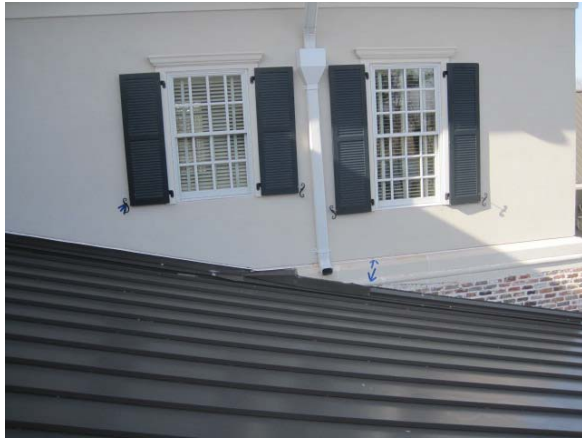
1. The step gable closest to the front of the building (1) has leaks at its caulking, flashing, and stucco penetrations. There is also a gap where drip edge above the masonry band is not caulked.

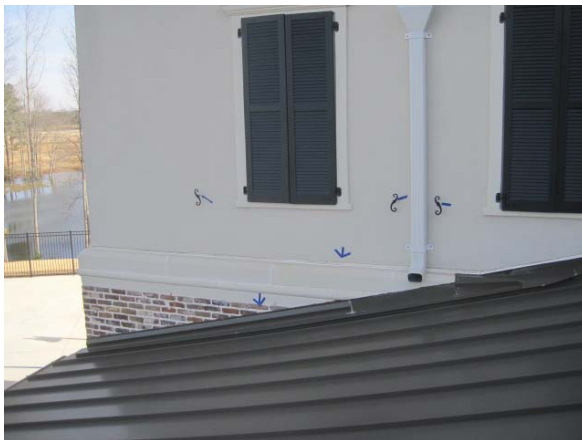
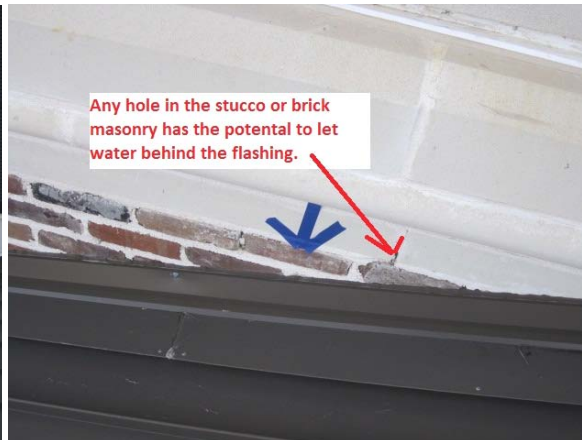
2. The corresponding step gable (2) at the left side near the rear of the building has similar problems.

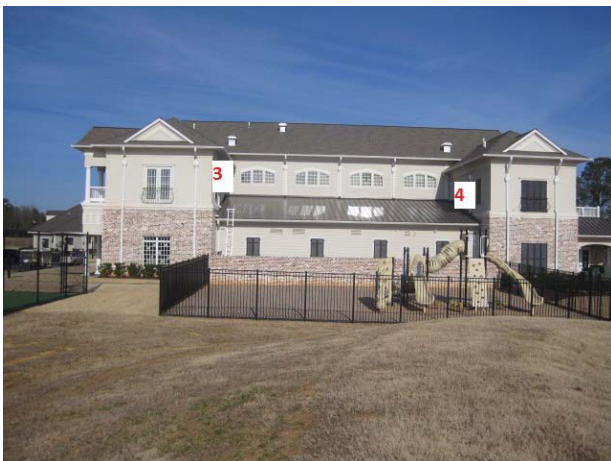
Step gables 3 & 4 at the right side of the building.

3. Gables 3 & 4 on the right side of the have the same problems as seen at the two left side gables.

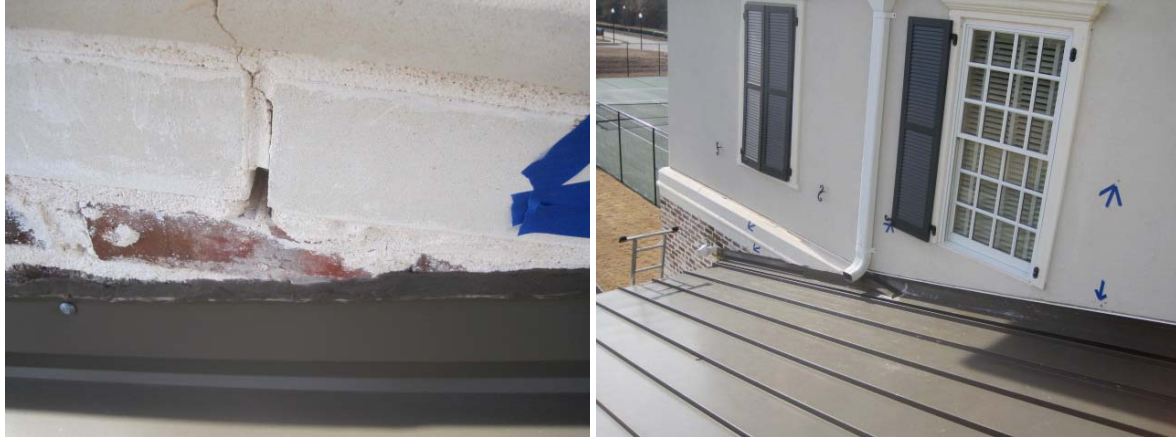
4. Gable 3 needs all its shutter bracket penetrations sealed. Holes from a missing shutter need sealed. Weep holes in the cement band that separates the stucco from the brick will allow water behind the stucco. Gaps in caulking need to be filled.

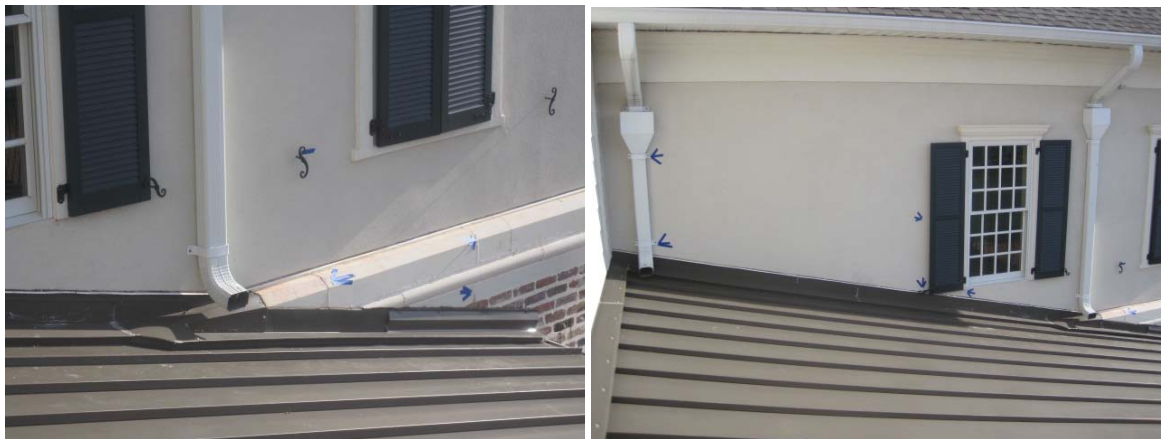
5. Gable 4 has the same problems as noted in gable 3 above (other than the missing shutter).

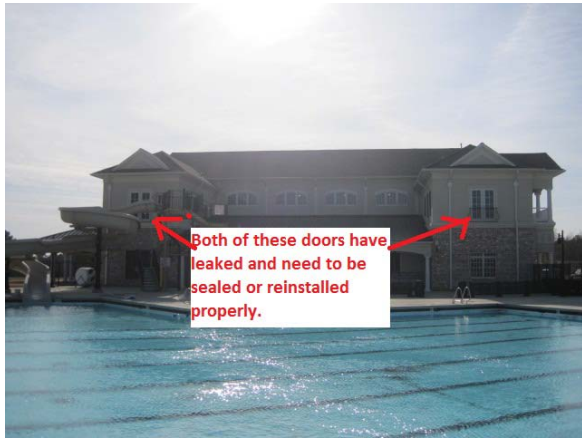
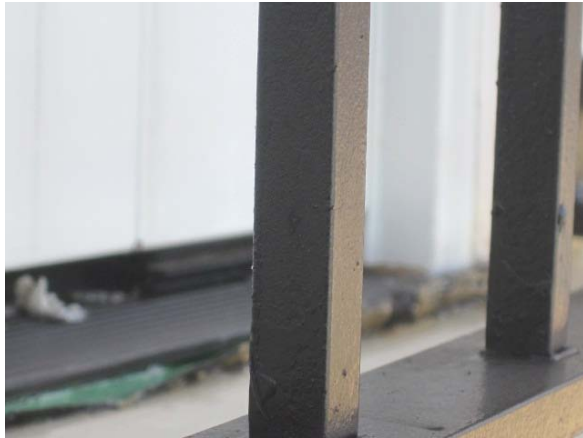
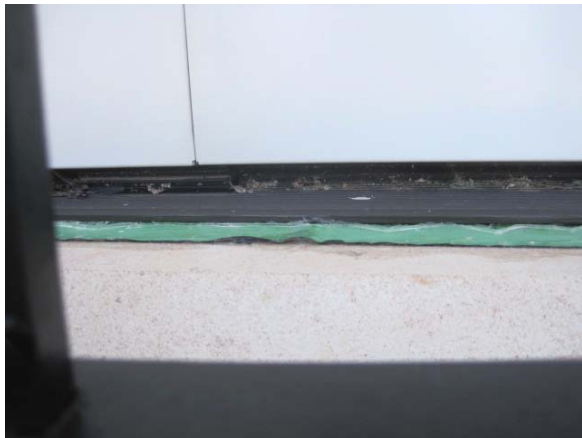
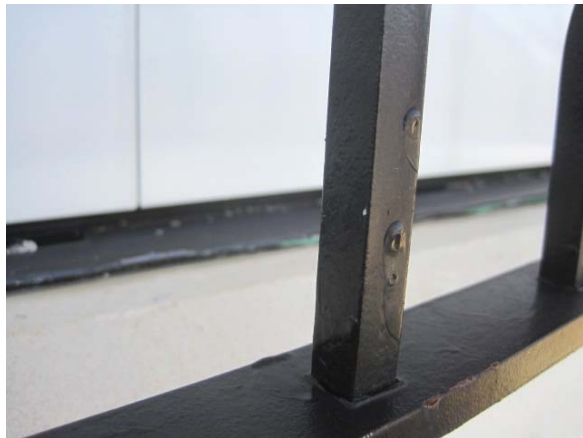
Four decorative doors with rails (2 on each side of the building) have gaps at their thresholds and can leak.

6. These two decorative doors are at the left side of the building. They both need to be sealed or reinstalled properly.

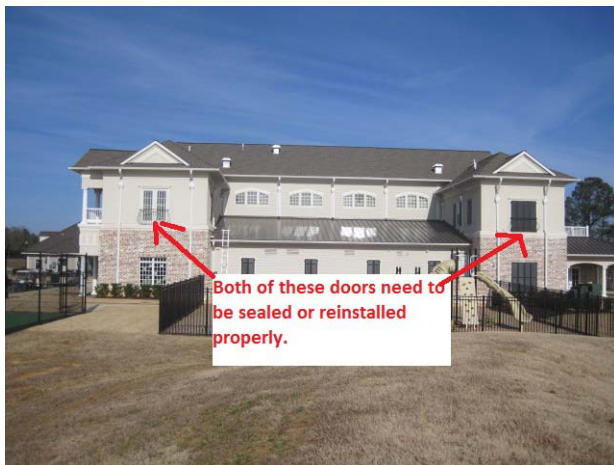
7. These two doors have the same problem at the right side of the building. They both need to be sealed or reinstalled properly.

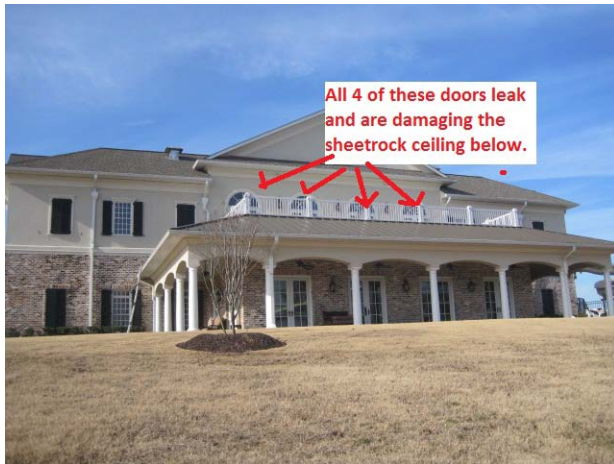
There are several active leaks in the building. There is an active leak above the walkway between the pool and spa (under the four doors above this area that go between the balcony and second floor weight area). All four of the doors leak and need to be sealed properly. Because the pitch of the balcony/roof is so flat, it may be necessary to raise the doors to prevent water entering from their thresholds. This would require a step up and step down on both sides of the wall. However the repairs are completed, a general contractor should assure the doors are properly sealed to prevent water from entering around or under them.

The rear balcony doors are causing the most penetration inside the building.

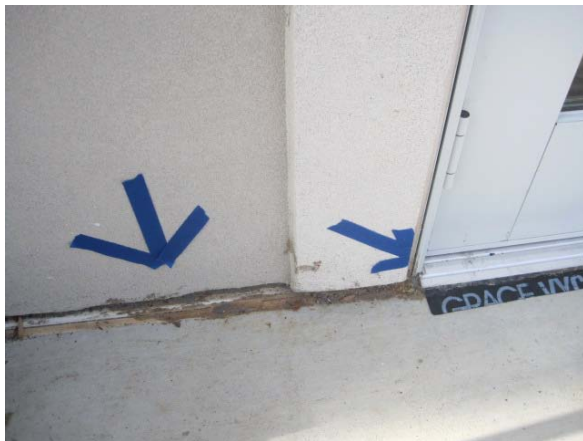
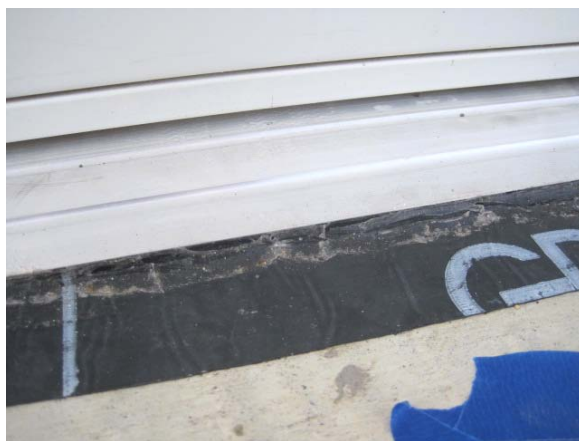
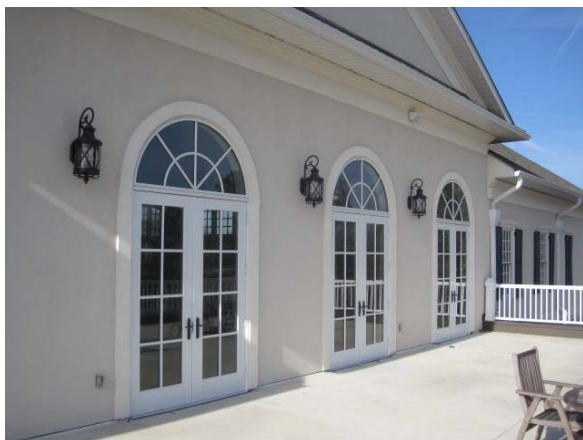
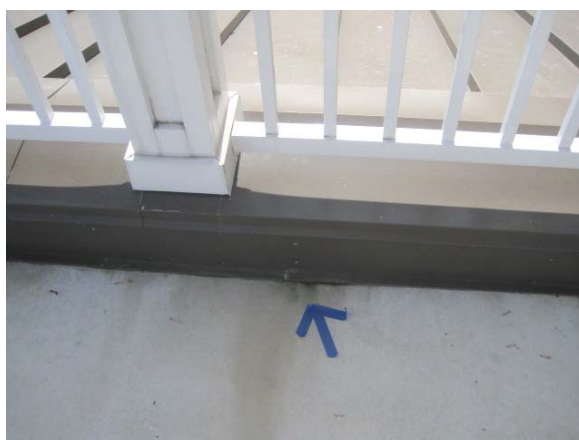
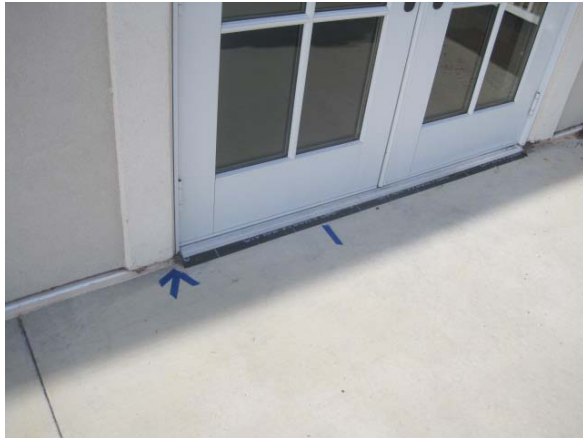
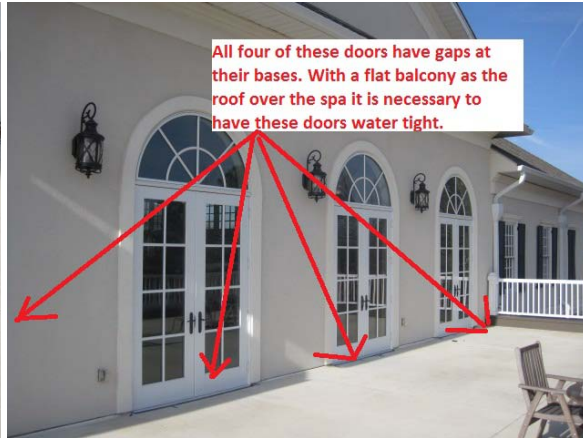
8. The following pictures are of the rear balcony door thresholds and the flat balcony itself. All 4 sets of doors need to be properly sealed or reinstalled correctly so they do not leak.

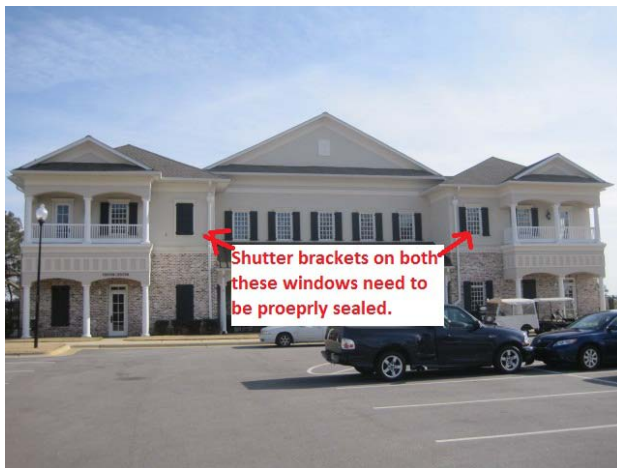
Front of the building

9. The front of the building has two windows that are exposed with shutter brackets penetrating the stucco that should be sealed.
