HOME INSPECTION REPORT

Address:
XXXXXXXXXXXXXXXX
XXXXXXXXXXXXXXXX

Age (year built): New Home (2010)

Structural and Mechanical Inspection

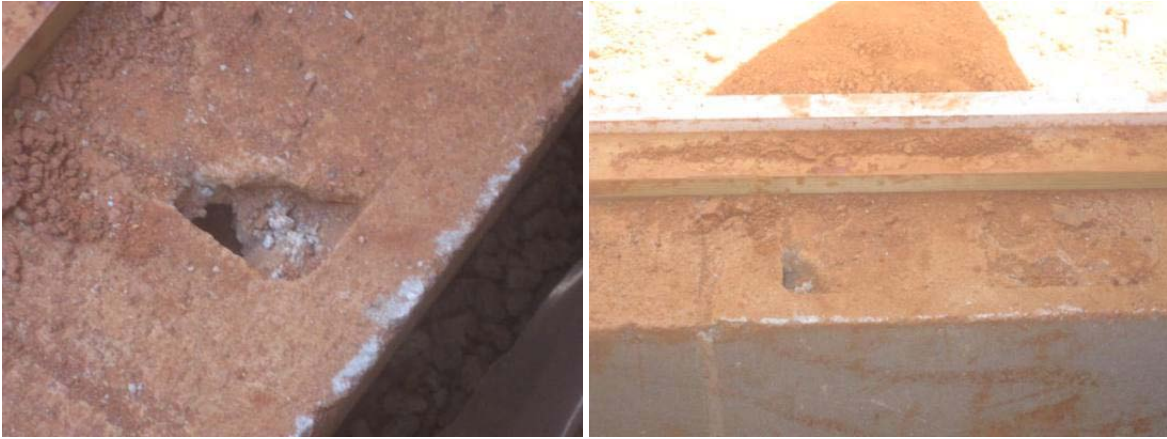
2. [A void in a block cap needs to be filled where there is a hole at the base of the crawlspace access door. The top of all the foundation is supposed to be at least 3-4 inches of solid masonry construction.]

1. A void in a block cap needs to be filled where there is a hole at the base of the crawlspace access door. The top of all the foundation is supposed to be at least 3-4 inches of solid masonry construction.

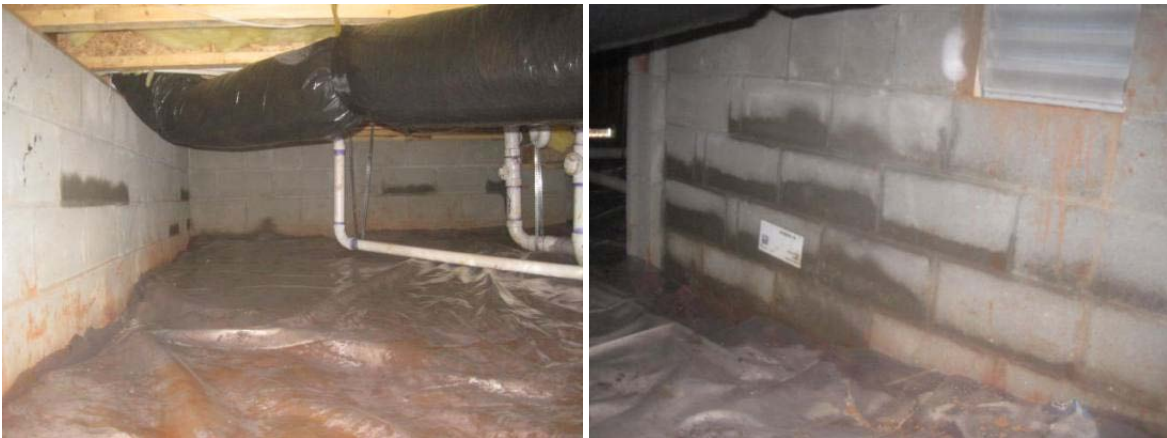
3. [Some water stained block at the front foundation wall at the left side of the front indicates that the mulch beds are holding too much water and the soil beneath does not adequately slope away from the home. Diverters added to the downspouts away from the foundation will also help the moisture problem.]

2. Some water stained block at the front foundation wall at the left side of the front indicates that the mulch beds are holding too much water and the soil beneath does not adequately slope away from the home. Diverters added to the downspouts away from the foundation will also help the moisture problem.

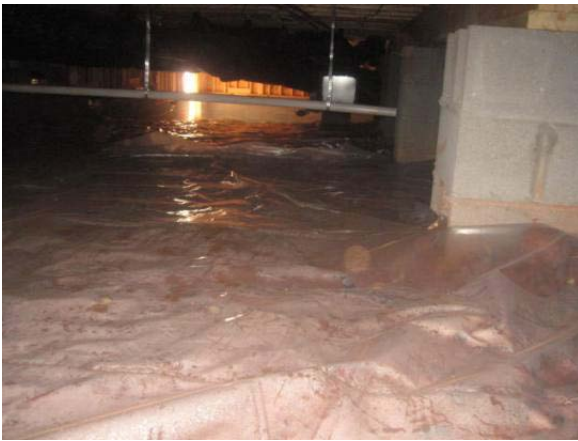
8. The crawlspace is vented with foundation vents. The dirt floor of the crawlspace is covered with a plastic vapor barrier.

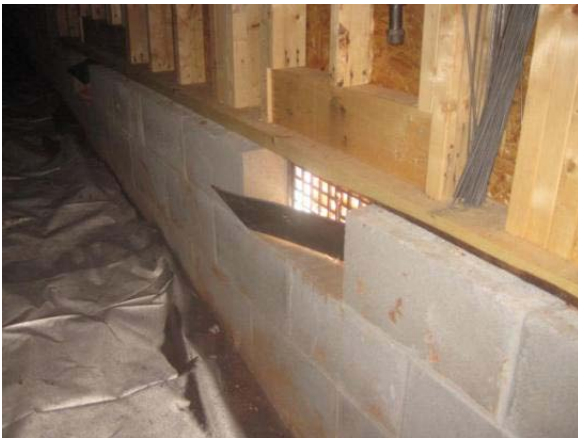
9. [A vent flap is loose in the rear crawlspace and should be secured.]

3. A vent flap is loose in the rear crawlspace and should be secured.
4. The upper gable portion of the attic needs an air outlet to allow hot air to exit the highest most portion of the attic.

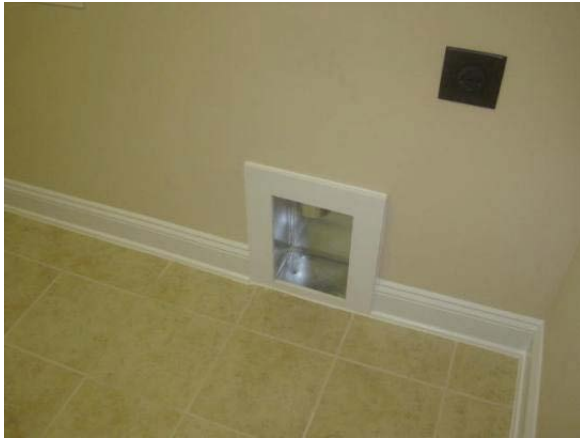
10. The foundation vents should be left opened year round and closed when the temperature gets below freezing.
11. The gas stove top venthood in the kitchen vents to the exterior.
12. The dryer vent was observed exiting and exhausting to the rear of the home.
13. The vent for the dryer runs vertical. Routine care should be taken to insure the vent duct does not become clogged.

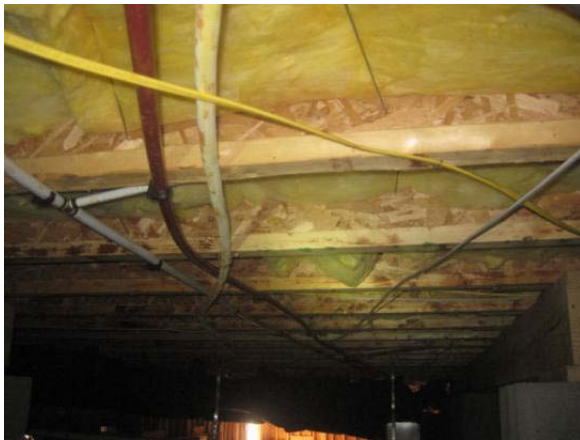
14. The crawlspace is insulated with 6 inch fiberglass batts without a paper vapor barrier. The paper barrier is not required since the crawlspace has a plastic vapor barrier below.

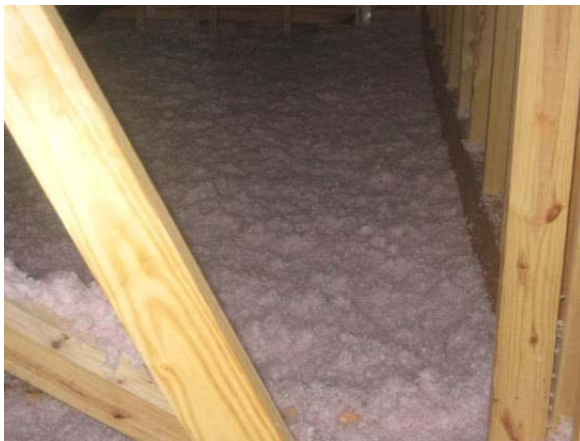
15. The attic is insulated with 11-12 inches of blown material. A vapor barrier is not present on the blown attic insulation nor is it required. The wall insulation is not visible. The insulation under the attic flooring is not visible.

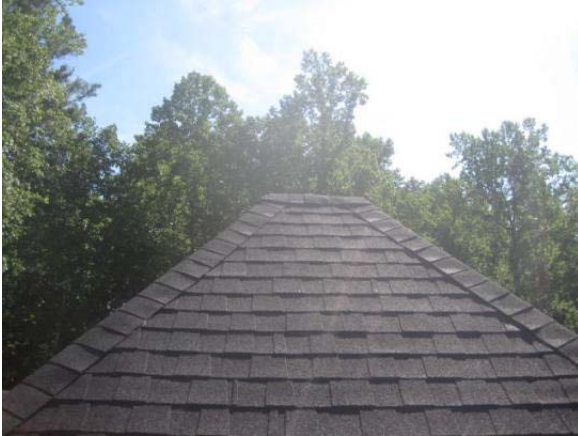
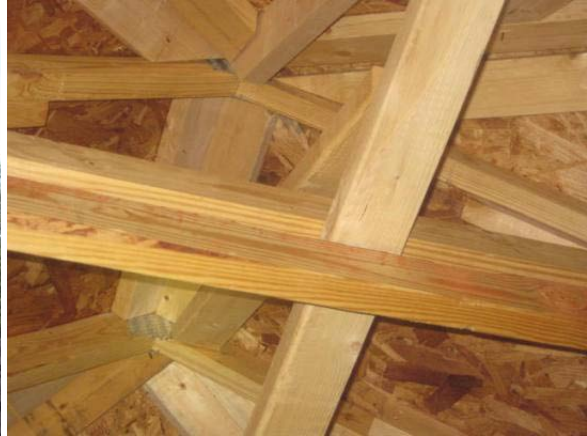
16. The attic is ventilated with soffit vents, gable vents, and ridge vent.
17. [The upper gable portion of the attic needs an air outlet to allow hot air to exit the highest most portion of the attic.]

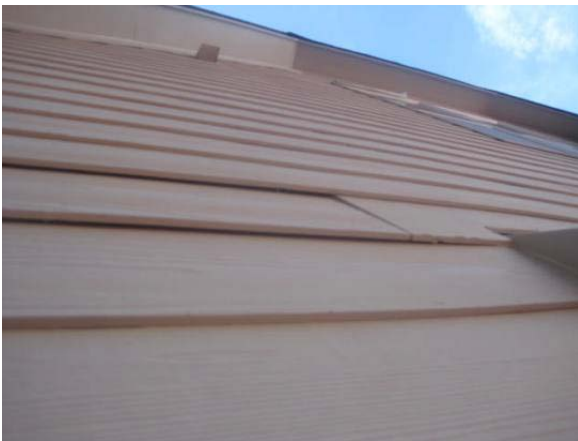
18. The exterior of the home is covered with Hardiplank masonry siding, manufactured stone veneer, particle board and wood trim.
19. **[A piece of siding needs to be face nailed at its joint to bring its top out to close an excessive gap at the left side of the home.]**

5. A piece of siding needs to be face nailed at its joint to bring its top out to close an excessive gap at the left side of the home.
6. Recommended language related to the incorrect installation of artificial stone siding:

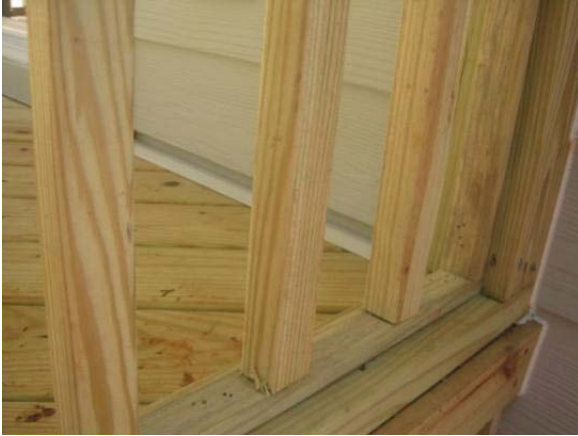
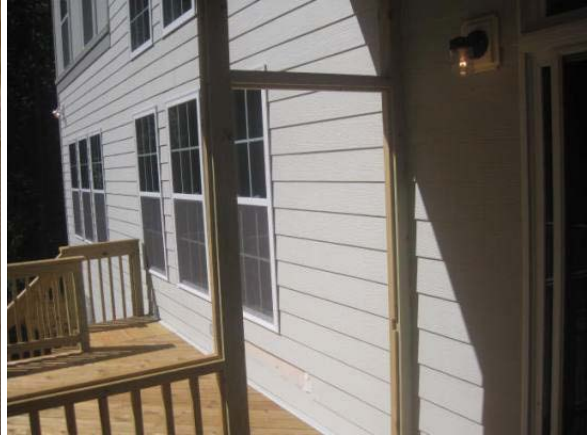
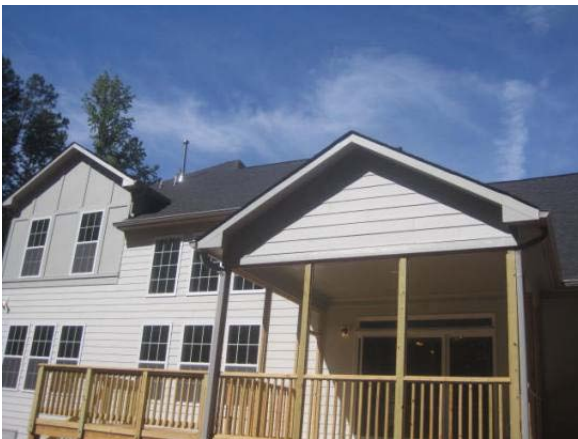
21. Positive drainage should be maintained all around the house. Positive drainage means the soil slopes away from the foundation.
22. Flashing was observed between the rear wood deck and the house. The screens were not yet installed on the covered portion of the porch. A door was not there yet either.

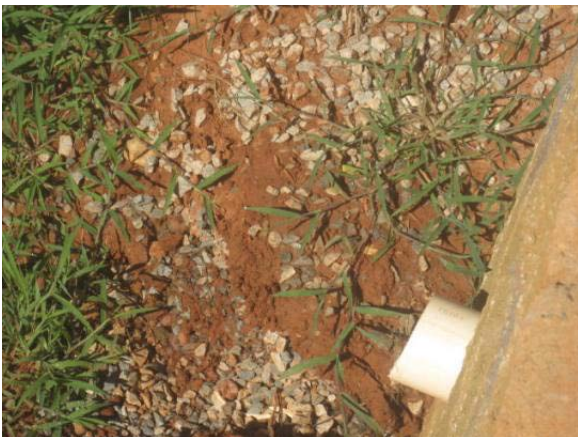
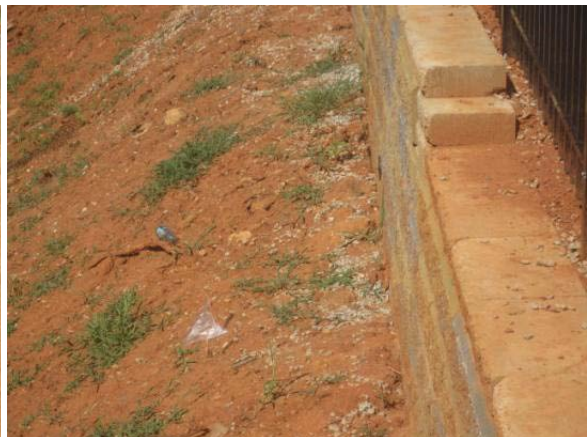
23. A large block retaining wall was observed at the right side of the home. The wall has some pipe outlets to allow water to escape from behind the wall and water was observed running out of a pipe here. The retaining wall appears to be in close enough proximity to the house foundation that problems may occur if the wall was to ever fail. I recommend annual or semiannual visual inspections of the retaining wall for any signs of failure.

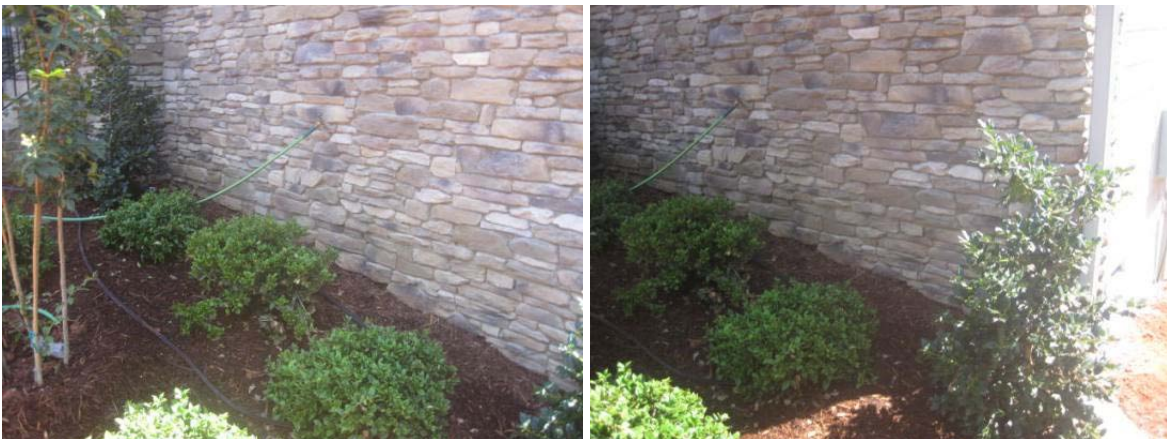
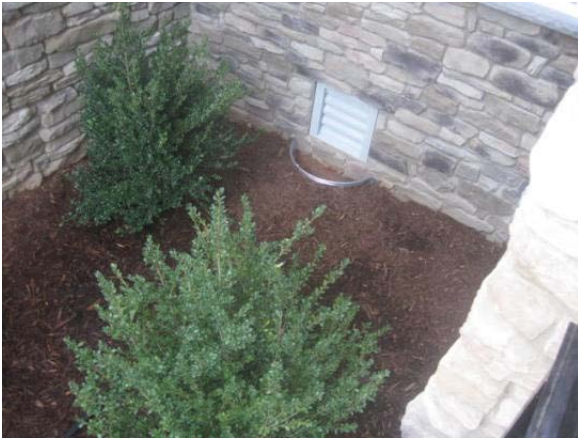
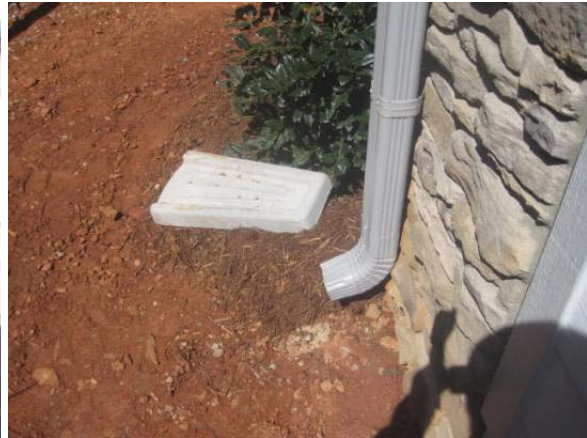
Manufactured stone veneer has been installed on the front of this house. An inspection of the visible components has revealed that the stone veneer has not been installed in compliance with installation guidelines provided by the Masonry Veneer Manufacturer’s Association (MVMA). A PDF copy of the installation guidelines is available at <http://www.masonryveneer.org/pdf/mvma030909.pdf> .

- Weep screeds are missing at the base of the wood frame walls.**
- Weep screeds are missing at the tops of window and door openings.**
- There is no caulk between other materials and the masonry veneer at windows, doors, and adjacent trim.**
- The masonry veneer is in contact with the ground.**
- Kick-out flashings are missing where roof eaves meet the masonry veneer.**

The lack of proper detailing and flashing may result in water penetration behind the siding, resulting in structural damage. The installation of the manufactured stone veneer should be evaluated, compared to the specific installation requirements of the stone manufacturer and the MVMA, and repaired or replaced as deemed necessary by a licensed general contractor or masonry contractor experienced with installation requirements for manufactured stone veneer.

Please note that because the water resistive barrier, metal lath, and base coat(s) of cement stucco are completely concealed behind the manufactured stone veneer, they cannot be evaluated by a visual inspection.

Manufactured stone veneer has been installed on the front of this house. An inspection of the visible components has revealed that the stone veneer has not been installed in compliance with installation guidelines provided by the Masonry Veneer Manufacturer's Association (MVMA). A PDF copy of the installation guidelines is available at <http://www.masonryveneer.org/pdf/mvma030909.pdf> .

The lack of proper detailing and flashing may result in water penetration behind the siding, resulting in structural damage. The installation of the manufactured stone veneer should be evaluated,

compared to the specific installation requirements of the stone manufacturer and the MVMA, and repaired or replaced as deemed necessary by a licensed general contractor or masonry contractor experienced with installation requirements for manufactured stone veneer.

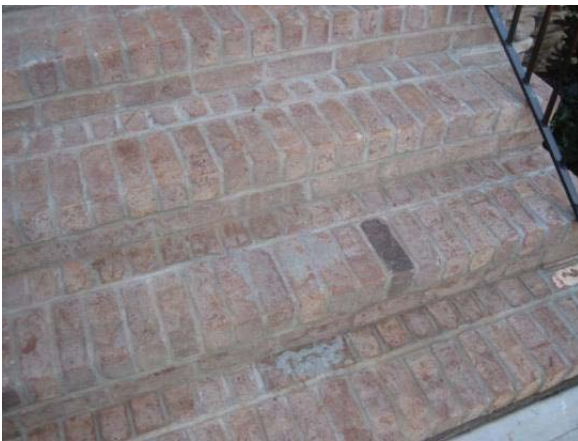
25. Mortar needs to be cleaned off the front brick steps.

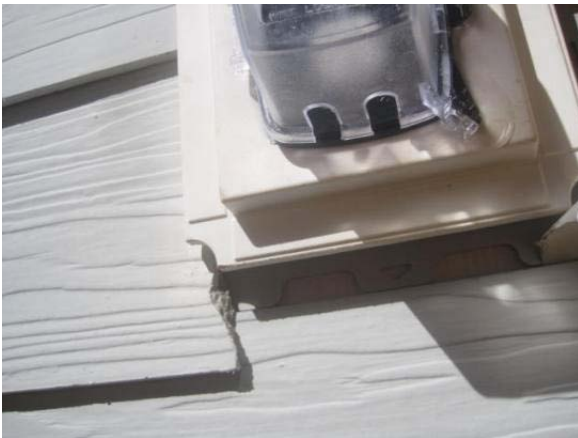
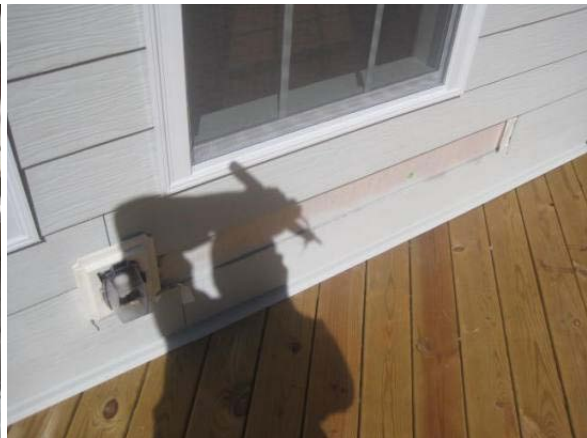
26. [A piece of masonry siding is missing above the rear wood deck.]

7. A piece of masonry siding is missing above the rear wood deck.
8. The circle flashing at the water heater exhaust is not installed properly as it will allow water to enter behind the flange.

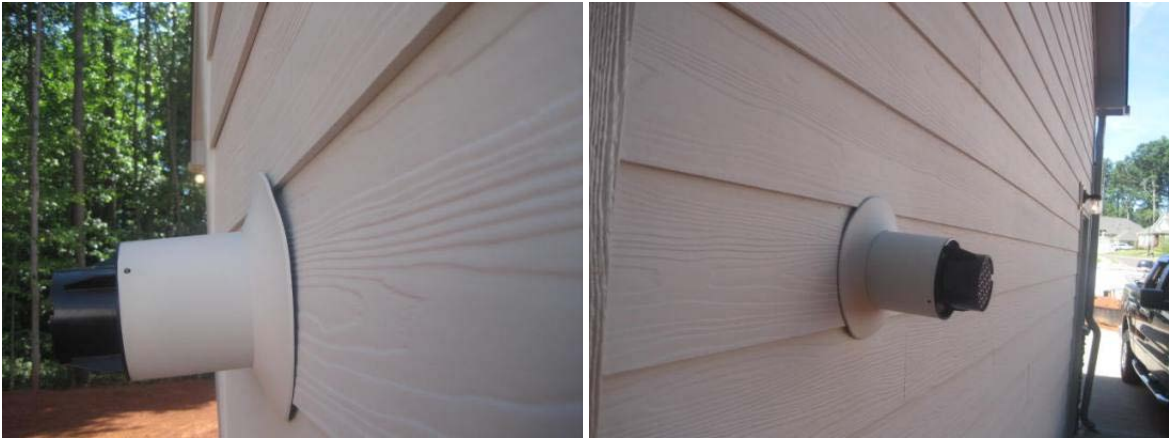
27. [The circle flashing at the water heater exhaust is not installed properly as it will allow water to enter behind the flange.]

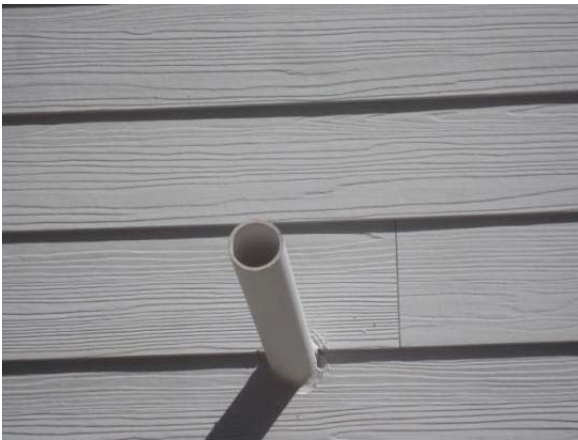
28. [The termination of the high efficiency furnace exhaust flue needs a screened cover to prevent birds from blocking the flue.]

9. The termination of the high efficiency furnace exhaust flue needs a screened cover to prevent birds from blocking the flue.
10. Splash blocks need to be installed properly under all the downspouts.

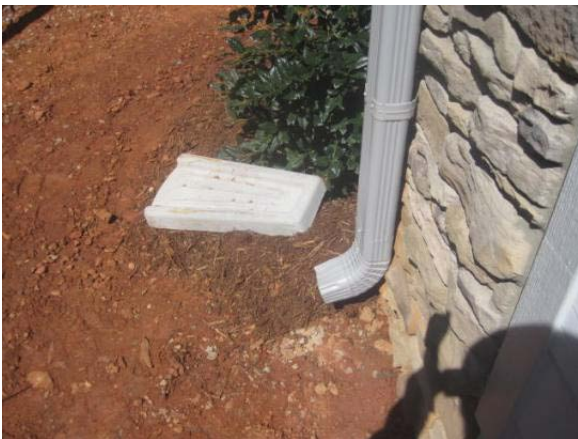
30. [Splash blocks need to be installed properly under all the downspouts.]

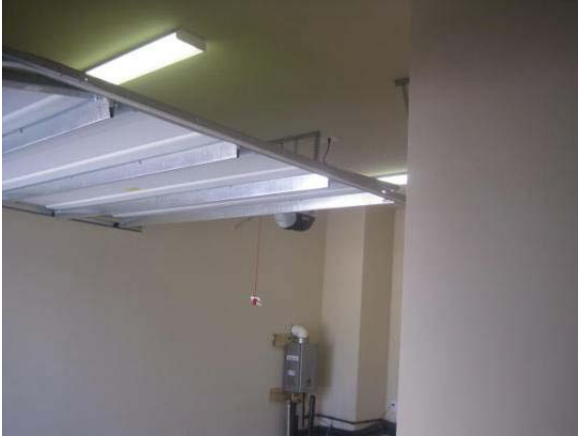
31. [An automatic opener operates the one car garage door. It is not operational and should be repaired by a qualified garage door technician familiar with automatic openers. The auto-reverse safety feature should be tested after the door opener is repaired.]

11. An automatic opener operates the one car garage door. It is not operational and should be repaired by a qualified garage door technician familiar with automatic openers. The auto-reverse safety feature should be tested after the door opener is repaired.

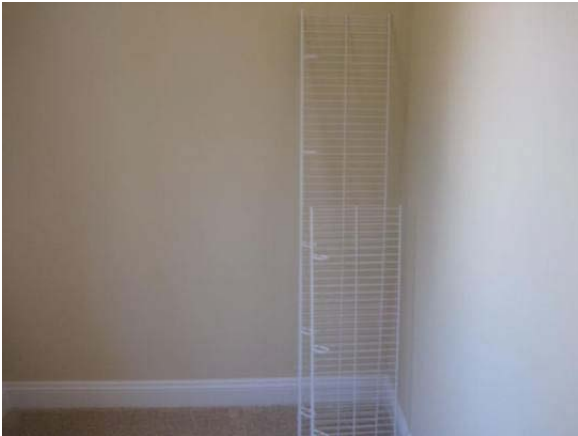
34. **[Some interior closet shelves are not installed.]**

12. Some interior closet shelves are not installed.
13. A piece of weather stripping is loose at a front living room window to the left of the front door. The weather stripping should be properly secured.

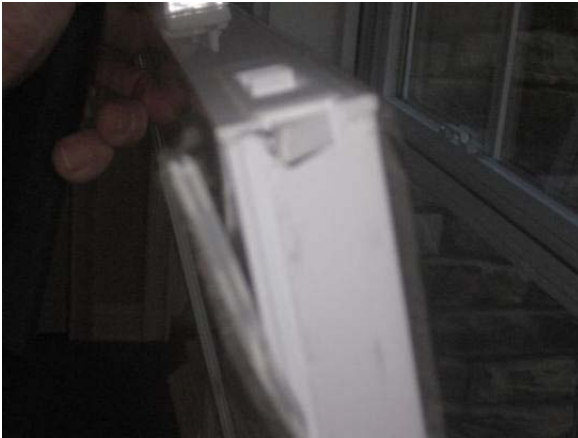
35. **[A piece of weather stripping is loose at a front living room window to the left of the front door. The weather stripping should be properly secured.]**

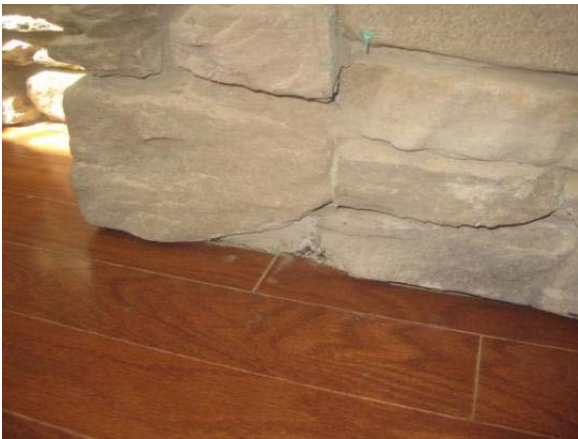
36. [A small stone is missing at the interior fireplace near the floor.]

14. A small stone is missing at the interior fireplace near the floor.
15. A master bath door is missing its hardware.
16. Sheetrock is damaged and should be repaired inside the hall leading to the garage where a door stop is needed and at the rear wall of the one car garage.

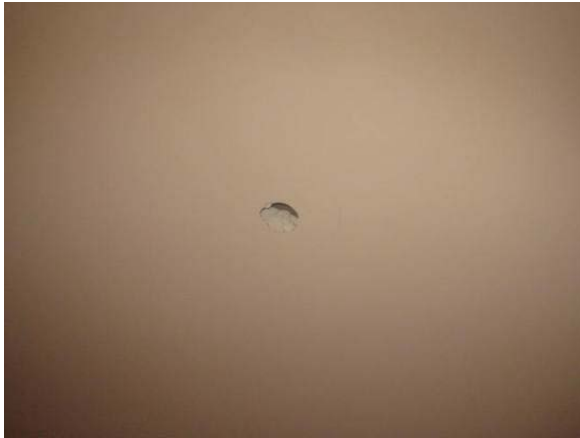
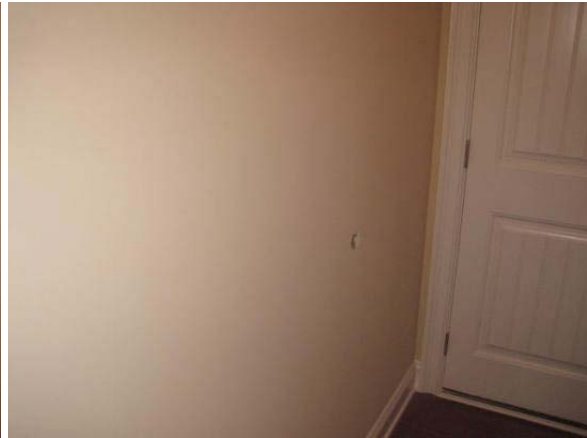
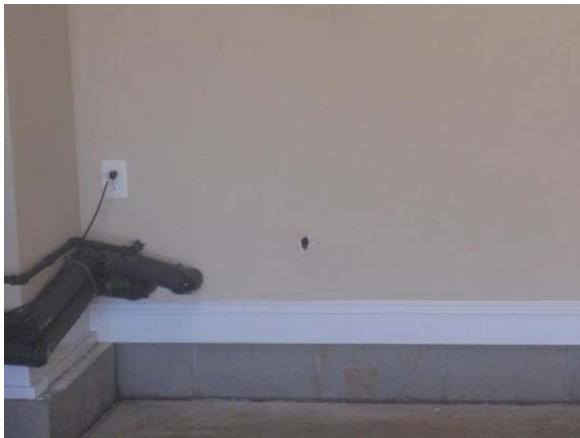
39. [Sheetrock is damaged and should be repaired inside the hall leading to the garage where a door stop is needed and at the rear wall of the one car garage.]

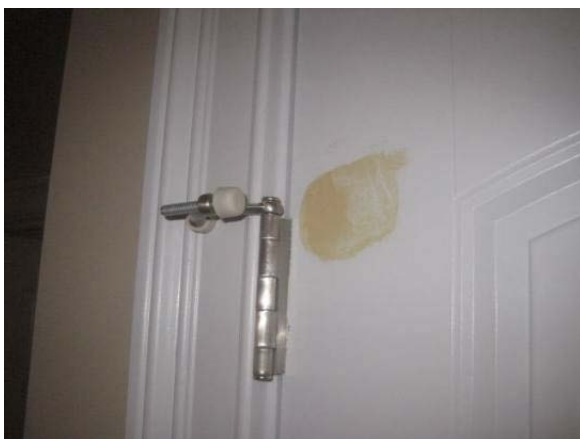
40. [A pantry door under the stair way is damaged where a hinge type doorstop punctured it. The door will need to be repaired in a professional manor or be replaced.]

17. A pantry door under the stair way is damaged where a hinge type doorstop punctured it. The door will need to be repaired in a professional manor or be replaced.

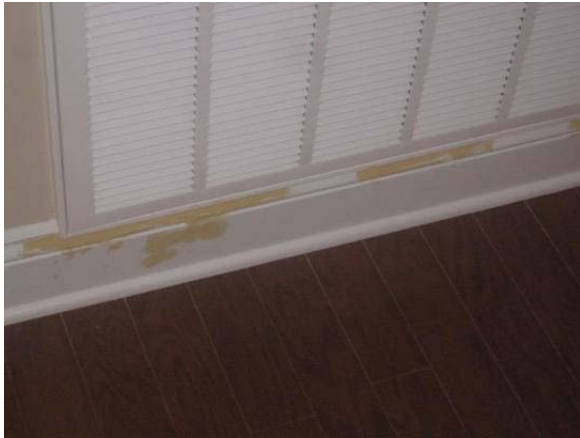
41. [Wood trim is puttied and not finished or painted by the return air register downstairs.]

18. Wood trim is puttied and not finished or painted by the return air register downstairs.
19. There are loose nails scattered about the roof. The loose nails should be removed.

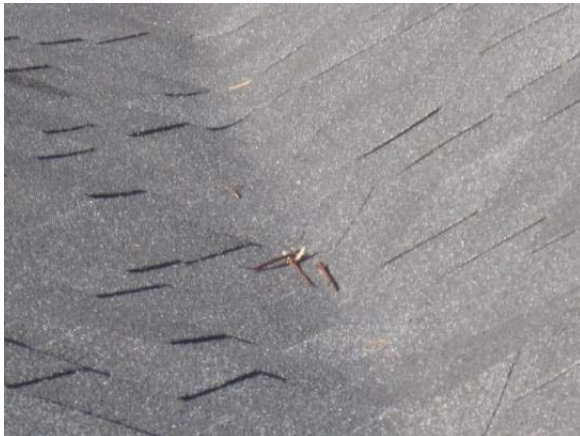
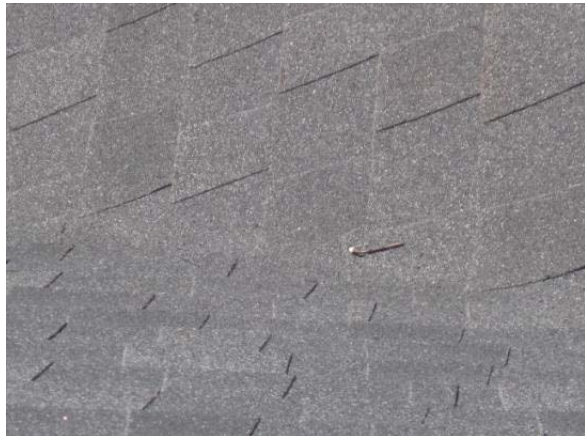
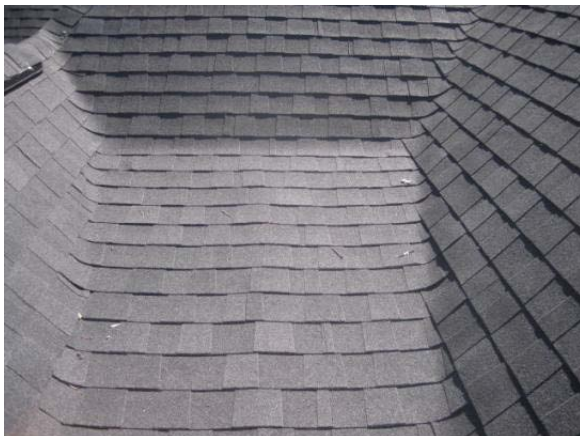
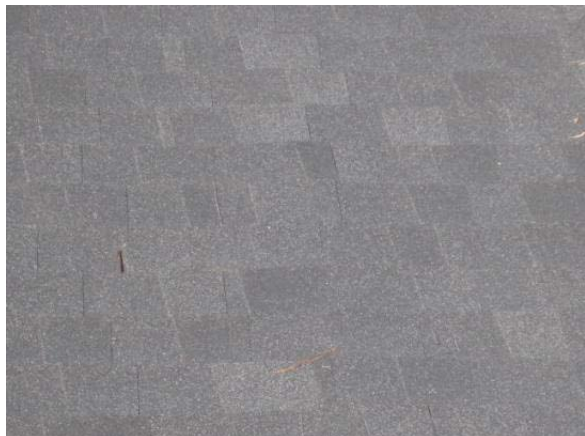
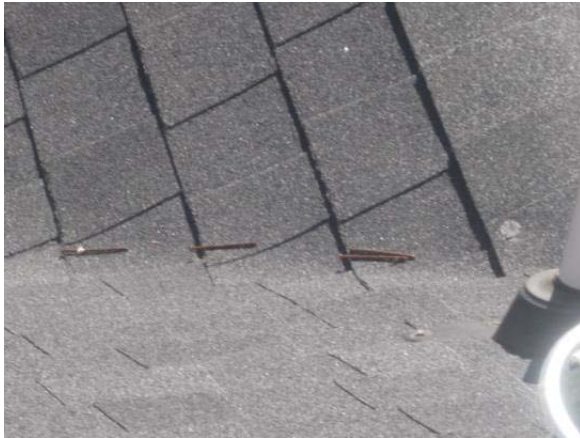
43. [There are loose nails scattered about the roof. The loose nails should be removed.]

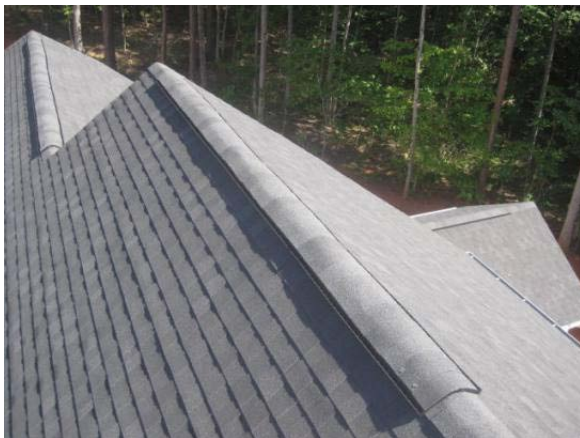
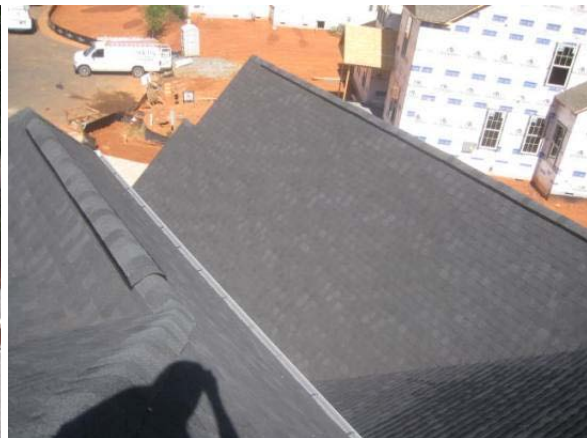
44. With the exception of the preceding item the asphalt shingle roof is in good condition. The flashing is done properly and the other roof penetrations are properly sealed.

45. The roof is a single layer and not a roof over.

46. The roof was observed by my physically walking on it.

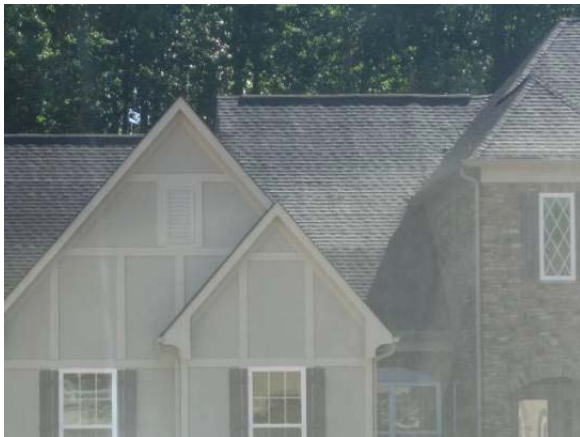
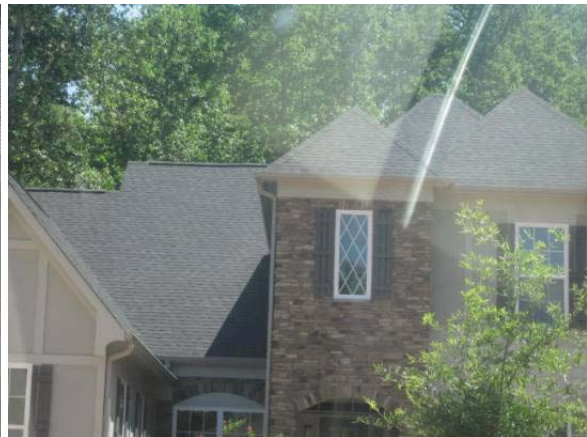
47. As I drove up to the house early in the morning I could see all the truss spacing from the front of the house. When I left a couple hours later the heat of the sun had flattened the roof and it looked normal.

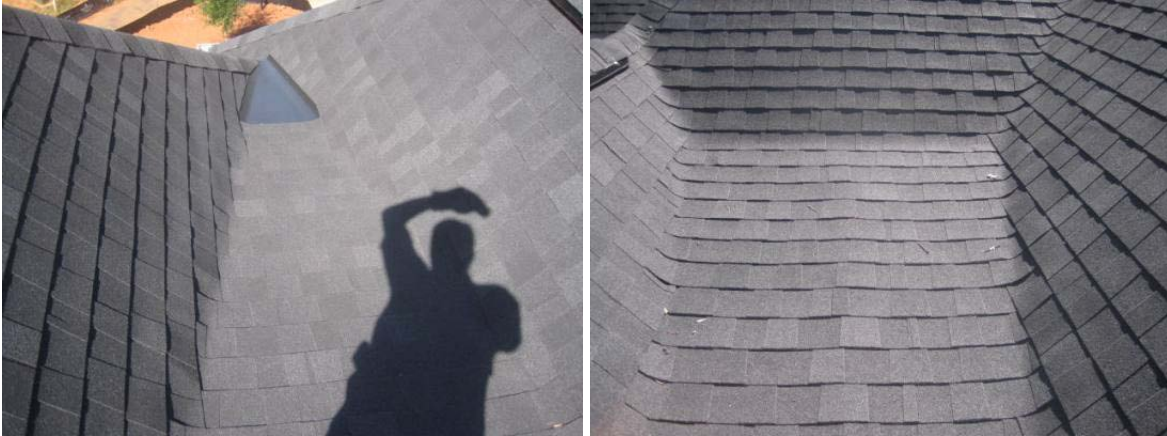
48. Manufacturers of asphalt shingle roofing recommend a minimum roof pitch of 2:12. Shingles installed on a pitch less than 2:12 may not leak initially but are more prone to leakage before there normal life

expectancy is over. They do not shed water as fast as a steeper pitch roof would. As they curl with age water is more likely to seep in at the seams. Also, there is a greater likelihood the shingles will let water in at the eaves, especially if there is no drip edge installed. The slightly sloped portion of the front roof is close to being 2:12. Confirm with the builder that the pitch of this roof is not less than 2:12 or a solid membrane or polymer roof would be needed.

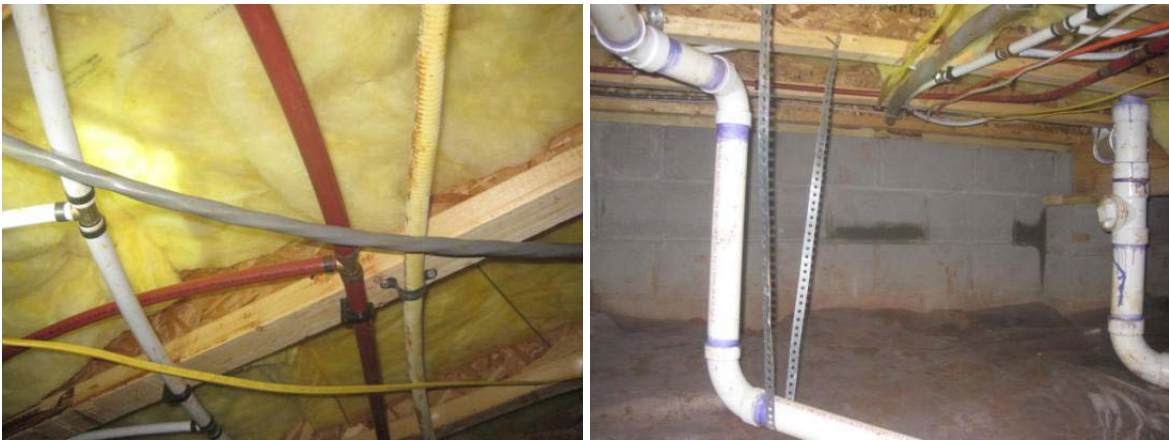
51. The service lines are polyethylene (Pex); the visible distribution lines are PEX plastic. The waste, drain, and vent lines are PVC plastic.

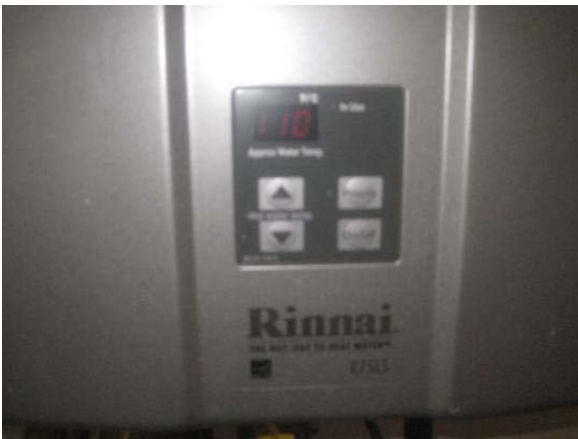
52. [The water heater is a natural gas tankless unit located in the one car garage. It is not functioning or started as there is no hot water in the house. A plumber should evaluate and correct this situation.]

20. The water heater is a natural gas tankless unit located in the one car garage. It is not functioning or started as there is no hot water in the house. A plumber should evaluate and correct this situation.

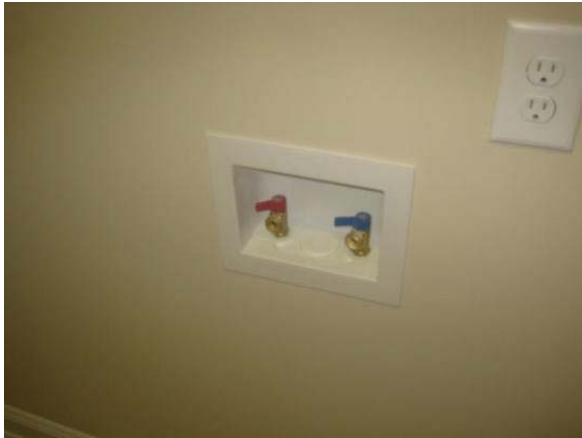
53. [The knockout cover needs to be carefully removed from the washing machine drain being careful not to drop it down into the drain.]

21. The knockout cover needs to be carefully removed from the washing machine drain being careful not to drop it down into the drain.
22. The crawlspace light is not operational. If the bulb is out it should be changed; if the unit is defective it should be replaced by a qualified electrician.

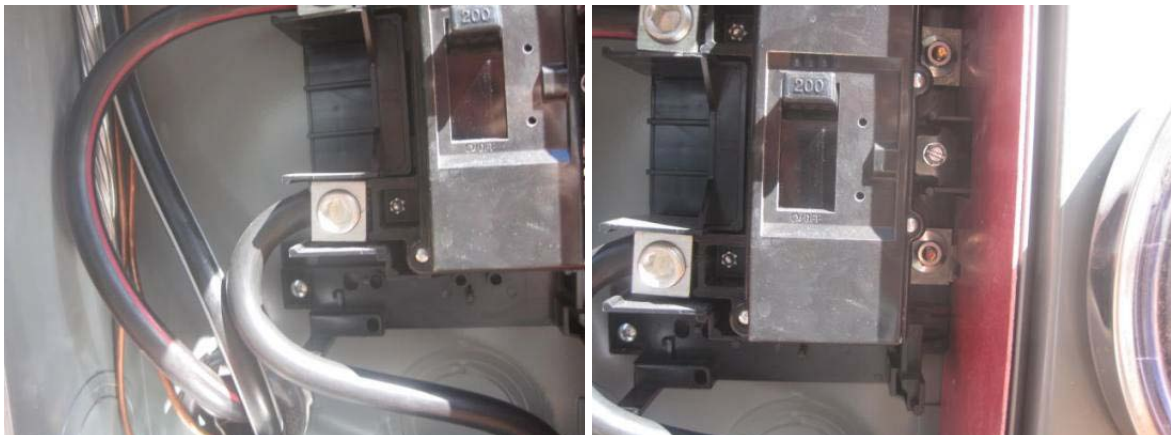
- 54. The home has underground service (220/110 volt) to the meter.
- 55. The main circuit breaker panel is located at the exterior of the home. It is a 200-amp service and is fed with 4/0 AWG aluminum entrance cable. This size service should be adequate for the home.

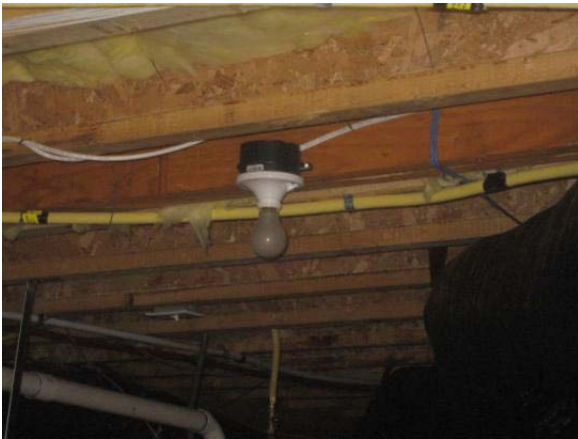
59. **[The crawlspace light is not operational. If the bulb is out it should be changed; if the unit is defective it should be replaced by a qualified electrician.]**

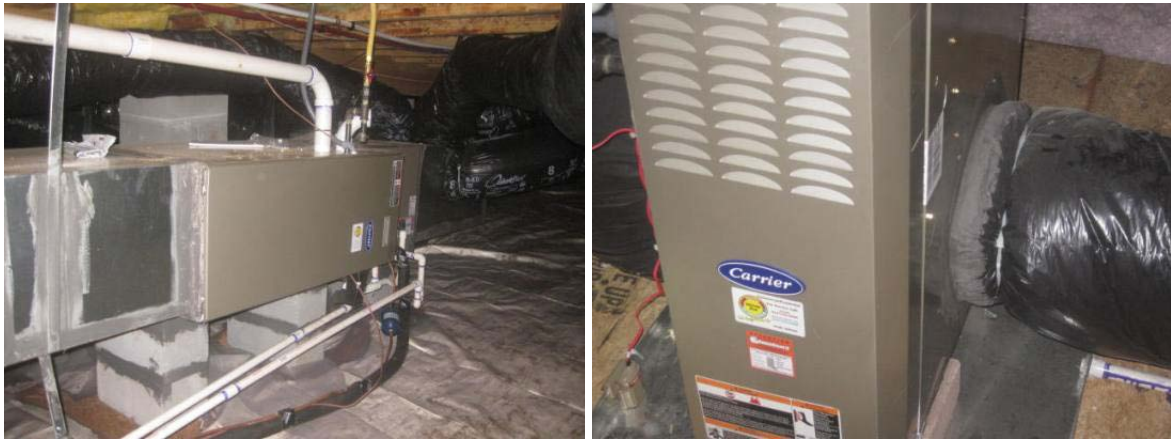
- 62. The house has two heating and cooling zones. A separate gas furnace and electric AC unit heats and cools both the upstairs and downstairs. The duct work consists of a metal plenum with flexible insulated ducts in the attic and crawlspace. This is referred to as two split systems.
- 63. The home is heated by two, gas, warm forced air furnaces. The furnace that heats the downstairs is located in the crawlspace. The furnace that heats the upstairs is located in the attic. Both of the furnaces are heating properly.

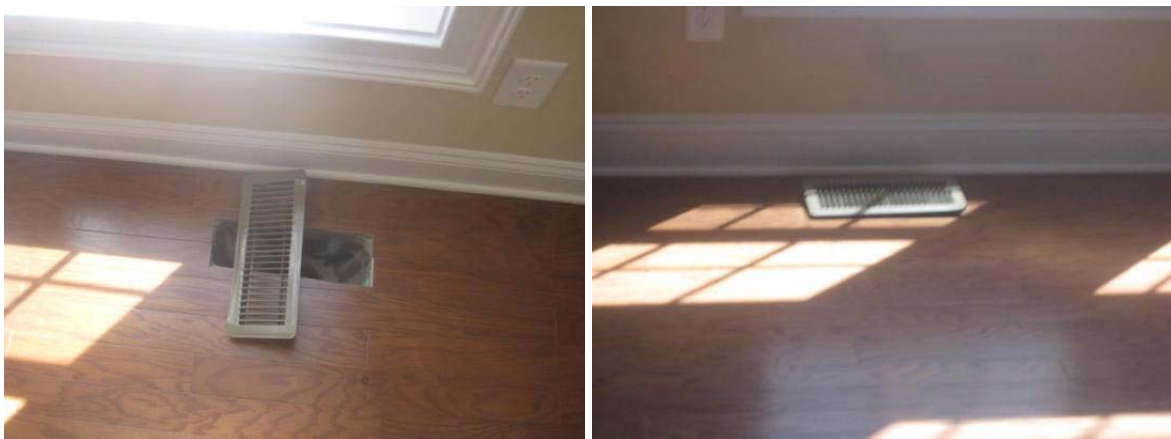
- 64. [Two floor registers do not fit their openings at the rear of the living room. An HVAC technician or wood floor person should correct the problem.]

23. Two floor registers do not fit their openings at the rear of the living room. An HVAC technician or wood floor person should correct the problem.

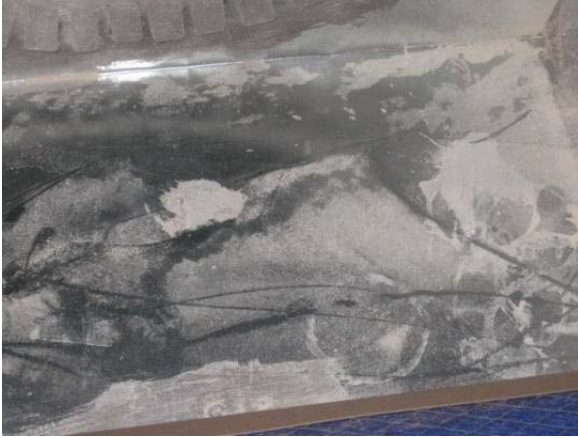
- 65. The filters for the return air system are located in the return air registers. The filters should be changed once a month before they become dirty.
- 66. The compartment on the downstairs return air unit has dust and dirt behind the filter that should be removed and the area should be cleaned.

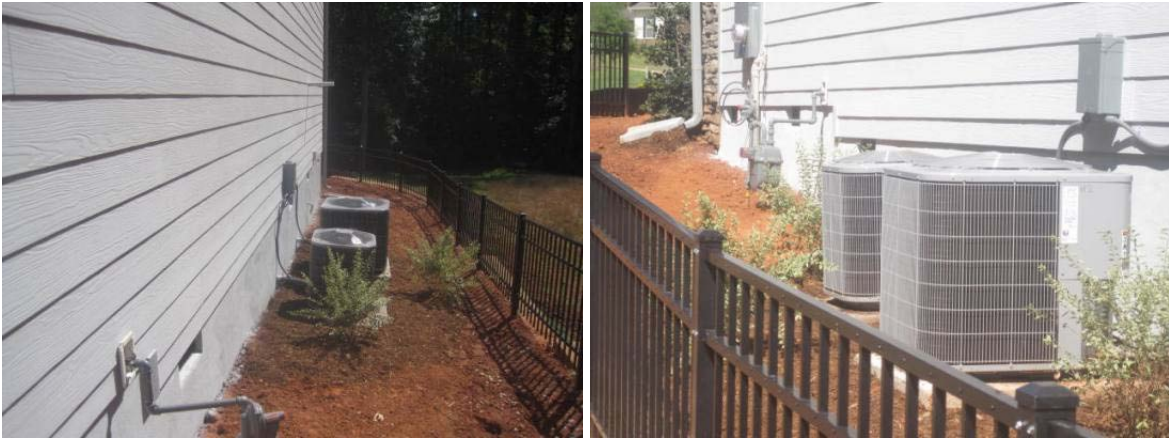
67. Two electric air-conditioning units located at the exterior of the home cool the home. Both of the units are cooling properly. They are part of the two split HVAC systems and share the same metal plenum and flexible ductwork the gas furnaces use.

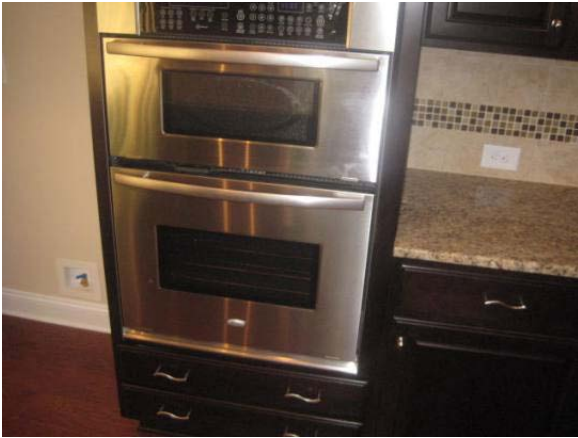
69. The electric oven was turned on. It was verified that all the elements were operational at the time of the inspection. The operation of the automatic cook cycle, automatic clean and thermostat were not verified.

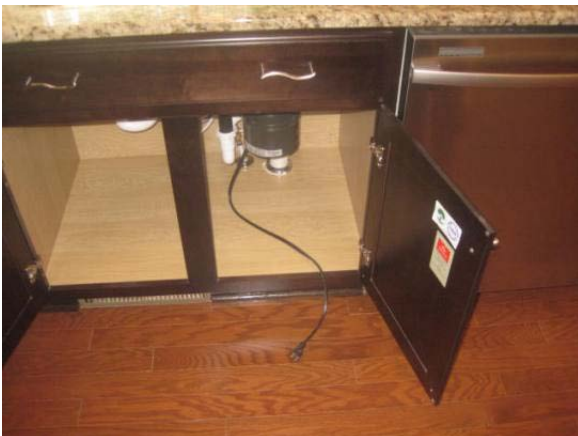
73. **[The disposal could not be operated as it was not plugged in. The drains from the kitchen sink made it impossible for me to plug the disposal into the receptacle. An electrician or combination of electrician and plumber should correct the problem to assure the disposal is hooked up properly and that it operates.]**

24. The disposal could not be operated as it was not plugged in. The drains from the kitchen sink made it impossible for me to plug the disposal into the receptacle. An electrician or combination of electrician and plumber should correct the problem to assure the disposal is hooked up properly and that it operates.
